Access Compliance Report

Public Rights-of-Way

(Curb Ramps)

| Intersection ID: 42483 | Main Street: BLAKENEY GREENS BV | Cross Street: BULLOCK GREENWAY BV | Location: E |

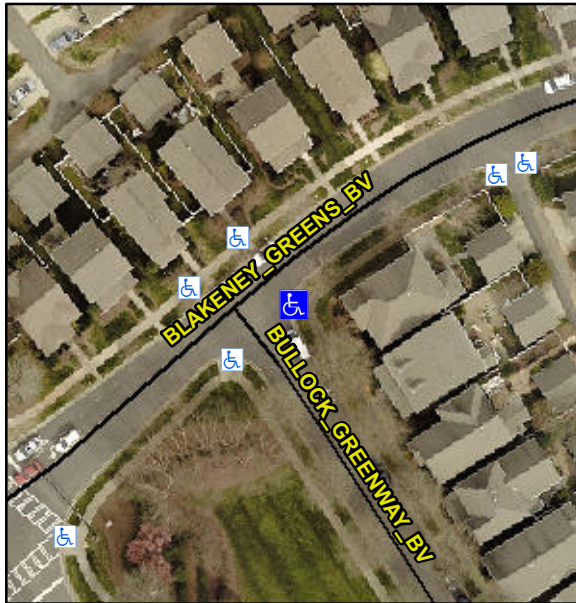
R304.5.1

| Compliance | Description | Data | Compliance | Description | Data |
|---|---|---|---|---|---|
| No | Ramp Width (in) | 32.0 | Yes | Ramp XSlope (%) | 1.4 |

Possible Solutions:

Remove & Replace Curb Ramp With Two New Directional Ramps or Equivalent.
