Access Compliance Report

Public Rights-of-Way

(Curb Ramps)

Intersection ID: 27357	Main Street: TILLEY MANOR DR	Cross Street: N/A	Location: W
ADA ID: D6B295FA2C67	Ramp Type: BlendTrans1	Initial Pass/Fail: Fail	Overall Compliance: No
Codes/Mitigation Info/Possible Solution		Field Measurements/Component Compliance	
Severity Score: 12.5

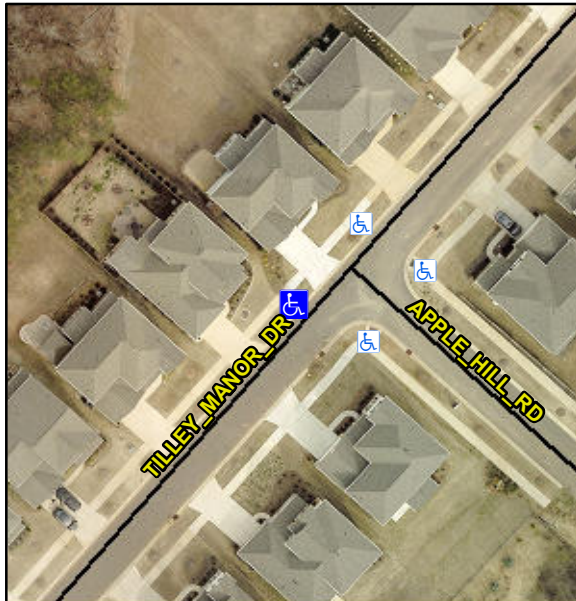
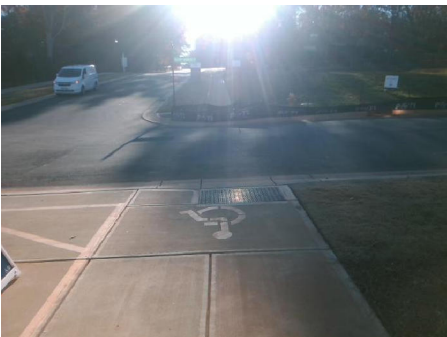
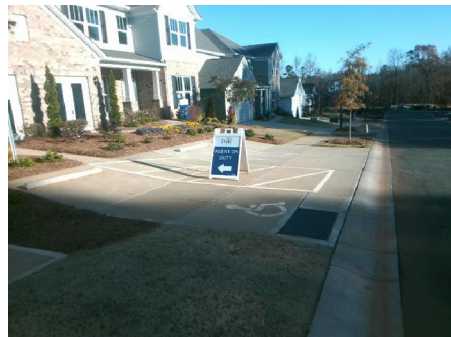
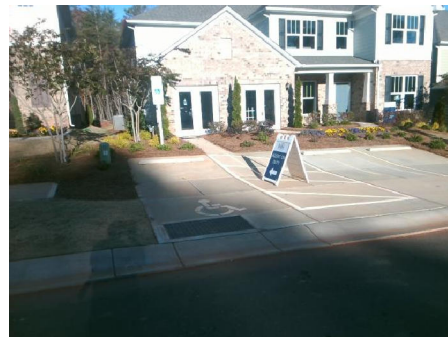
Not Found, R304.5.3

Compliance	Description	Data	Compliance	Description	Data
N/A	Ramp Length (in)	29.0	Yes	BlendTrans Slope (%)	2.3
Yes	Ramp Width (in)	48.0	No	BlendTrans XSlope (%)	5.7
N/A	Flare Type LT	N/A	N/A	Flare Type RT	N/A
N/A	Flare Slope LT (%)	N/A	N/A	Flare Slope RT (%)	N/A
N/A	Flare Traversable LT?	N/A	N/A	Flare Traversable RT?	N/A
N/A	Landing Length (in)	N/A	N/A	DWS Provided?	N/A
N/A	Landing Width (in)	N/A	N/A	DWS Contrast?	N/A
N/A	Landing Slope (%)	N/A	N/A	DWS Length (in)	N/A
N/A	Landing X Slope (%)	N/A	N/A	DWS Full Width?	N/A
N/A	Landing Curb? (Y/N)	N/A	N/A	DWS Offset (in)	N/A
N/A	Shared Landing?	N/A			
N/A	Gutter Ponding?	N/A	N/A	Gutter Slope (%)	N/A
N/A	Gutter Lip Ht (in)	N/A	N/A	Gutter X Slope (%)	N/A
N/A	Painted X Walk1?	No	N/A	Painted X Walk2?	N/A
	X Walk 1 Direction	To SE		X Walk 2 Direction	N/A
	X Walk 1 Width (in)	N/A		X Walk 2 Width (in)	N/A
	X Walk 1 Slope (%)	1.6		X Walk 2 Slope (%)	N/A
	X Walk 1 X Slope (%)	5.9		X Walk 2 X Slope (%)	N/A

N/A	Ramp inside XWalk1?	N/A	N/A	Ramp inside XWalk2?	N/A
	Road Slope (%)	5.9		Clear Space?	N/A
	Road X Slope (%)	1.6	N/A	Clear Space to XWalk (in)	N/A
N/A	Any Obstructions?	N/A	N/A	Storm Grate/Utility Hazard?	N/A
	Obstruction Type			Storm Grate/Utility Type	
		N/A			N/A
			Yes	Surface Condition? (G/P)	Good
			No	Curb Slope (%)	14.8

Remove & Replace Curb Ramp With Two New Directional Ramps or Equivalent.
