Access Compliance Report

Public Rights-of-Way

(Curb Ramps)

Intersection ID: 28201	Main Street: DONNINGTON_DR	Cross Street: CUMNOR_LN	Location: NW
ADA ID: D6B2C8002950	Ramp Type: BlendTrans2	Initial Pass/Fail: Fail	Overall Compliance: No
		Severity Score: 12.5

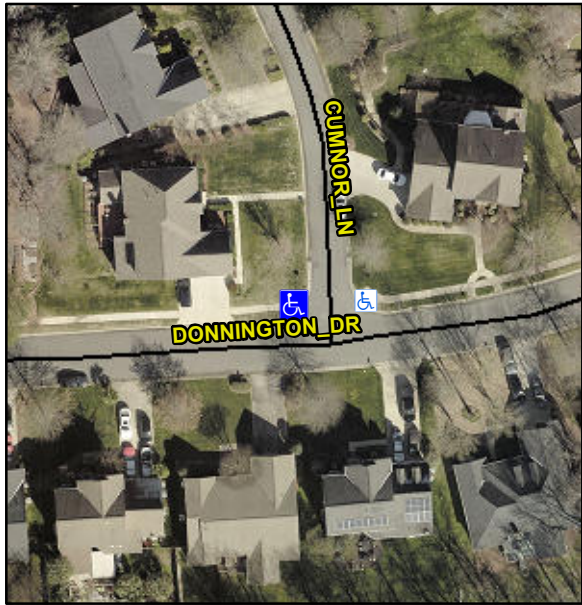
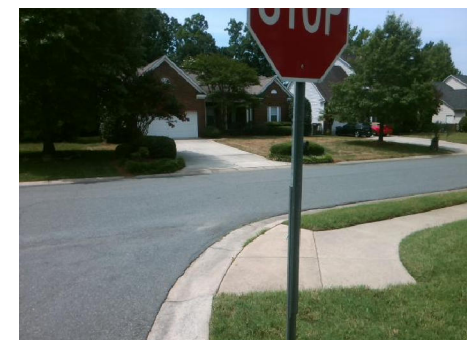
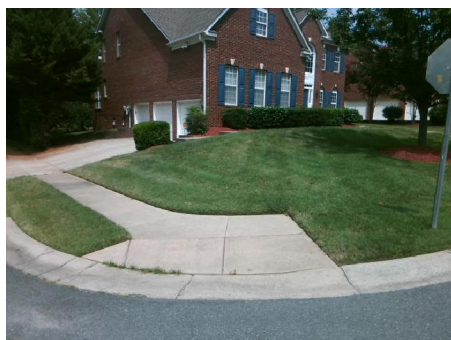
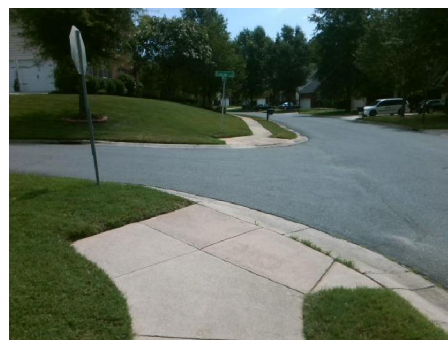
Possible Solutions:		Compliance	Description	Data	Compliance	Description	Data
	Remove & Replace Curb Ramp With Two New Directional Ramps or Equivalent.		N/A	Ramp Length (in)	95.5	Yes	BlendTrans Slope (%)	4.3
			Yes	Ramp Width (in)	107.0	No	BlendTrans XSlope (%)	5.4
			N/A	Flare Type LT	N/A	N/A	Flare Type RT	N/A
			N/A	Flare Slope LT (%)	N/A	N/A	Flare Slope RT (%)	N/A
			N/A	Flare Traversable LT?	N/A	N/A	Flare Traversable RT?	N/A
			N/A	Landing Length (in)	N/A	N/A	DWS Provided?	N/A
			N/A	Landing Width (in)	N/A	N/A	DWS Contrast?	N/A
			N/A	Landing Slope (%)	N/A	N/A	DWS Length (in)	N/A
			N/A	Landing X Slope (%)	N/A	N/A	DWS Full Width?	N/A
<p>Surveyor Notes:</p> <p>N/A</p> <p>PROW/ADA:</p> <p>Not Found, R304.5.3</p>			N/A	Landing Curb? (Y/N)	N/A	N/A	DWS Offset (in)	N/A
			N/A	Shared Landing?	N/A			
			N/A	Gutter Ponding?	N/A	N/A	Gutter Slope (%)	N/A

N/A	Gutter Lip Ht (in)	N/A	N/A	Gutter X Slope (%)	N/A
			N/A	Painted X Walk1?	No	N/A	Painted X Walk2?	No
				X Walk 1 Direction	To S		X Walk 2 Direction	To E
				X Walk 1 Width (in)	N/A		X Walk 2 Width (in)	N/A
				X Walk 1 Slope (%)	2.6		X Walk 2 Slope (%)	4.5
				X Walk 1 X Slope (%)	3.6		X Walk 2 X Slope (%)	3.4
			N/A	Ramp inside XWalk1?	N/A	N/A	Ramp inside XWalk2?	N/A
			Road Slope (%)	4.5		Clear Space?	N/A	
			Road X Slope (%)	1.5	N/A	Clear Space to XWalk (in)	N/A	
		N/A	Any Obstructions?	N/A	N/A	Storm Grate/Utility Hazard?	N/A	
			Obstruction Type			Storm Grate/Utility Type		
					N/A			N/A
						Yes	Surface Condition? (G/P)	Good
						No	Curb Slope (%)	9.7
