Access Compliance Report

Public Rights-of-Way

(Curb Ramps)

| Intersection ID: 43682 | Main Street: FARNSFIELD_CT | Cross Street: TODDINGTON_LN | Location: NE |

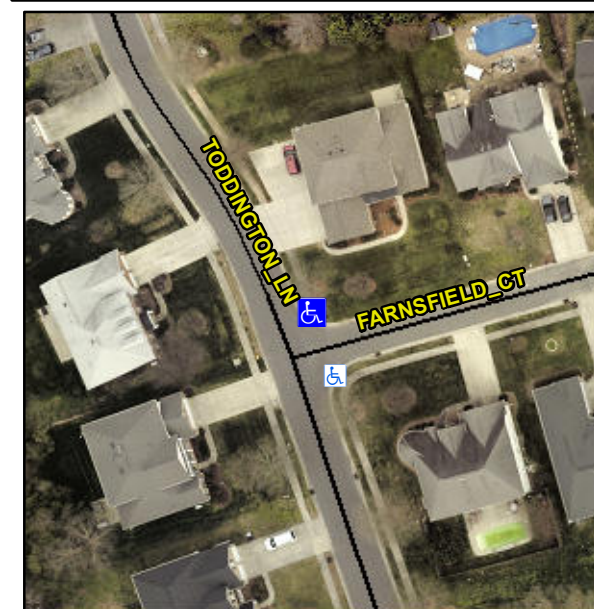
| ADA ID: D6B6374EBDF5 | Ramp Type: BlendTrans1 | Initial Pass/Fail: Fail | Overall Compliance: No |
| Severity Score: 8.75 | | | |

Not Found, R304.5.1

| Compliance | Description | Data | Compliance | Description | Data |
|---|---|---|---|---|---|
| No | Ramp Width (in) | 43.0 | Yes | BlendTrans XSlope (%) | 1.4 |
| | | | No | Curb Slope (%) | 9.0 |

Remove & Replace Curb Ramp With Two New Directional Ramps or Equivalent.

Total Cost: \$ 3200.00
