# Access Compliance Report

## Public Rights-of-Way

### (Curb Ramps)

Intersection ID: 47301	Main Street: WOODRUFF_PL	Cross Street: HURSTON_CR	Location:	N
ADA ID: D6BA16BB896E	Ramp Type: Perp	Initial Pass/Fail: Fail	Overall Compliance: No	Severity Score: 13.75

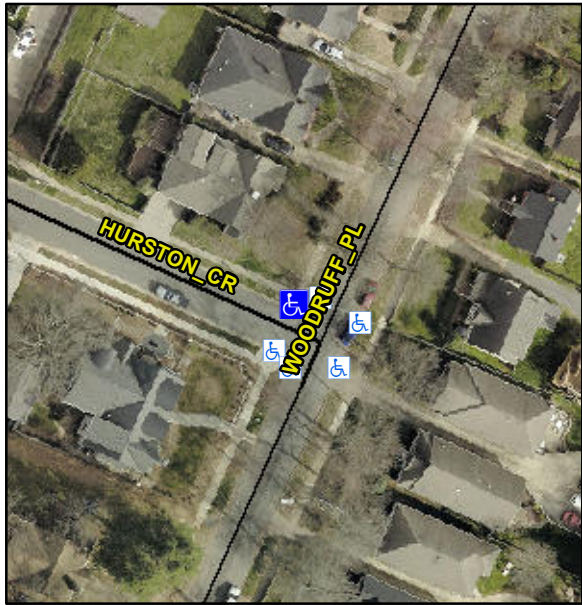
Possible Solutions:		Compliance	Description	Data	Compliance	Description	Data
	Remove & Replace Entire Ramp.		N/A	Ramp Length (in)	46.5	No	Ramp Slope (%)	11.7
			Yes	Ramp Width (in)	53.0	No	Ramp XSlope (%)	3.3
			N/A	Flare Type LT	N/A	N/A	Flare Type RT	N/A
			N/A	Flare Slope LT (%)	N/A	N/A	Flare Slope RT (%)	N/A
			N/A	Flare Traversable LT?	N/A	N/A	Flare Traversable RT?	N/A
			N/A	Landing Length (in)	N/A	N/A	DWS Provided?	N/A
			N/A	Landing Width (in)	N/A	N/A	DWS Contrast?	N/A
			N/A	Landing Slope (%)	N/A	N/A	DWS Length (in)	N/A
			N/A	Landing X Slope (%)	N/A	N/A	DWS Full Width?	N/A
Surveyor Notes:		N/A	N/A	Landing Curb? (Y/N)	N/A	N/A	DWS Offset (in)	N/A
PROW/ADA:		Not Found, R304.2.2, R304.5.3	N/A	Shared Landing?	N/A			
			N/A	Gutter Ponding?	Yes	N/A	Gutter Slope (%)	N/A
			N/A	Gutter Lip Ht (in)	N/A	N/A	Gutter X Slope (%)	N/A

N/A	Painted X Walk1?	No	N/A	Painted X Walk2?	N/A
				X Walk 1 Direction	To SW		X Walk 2 Direction	N/A
			N/A	X Walk 1 Width (in)	N/A	N/A	X Walk 2 Width (in)	N/A
				X Walk 1 Slope (%)	3.1		X Walk 2 Slope (%)	N/A
				X Walk 1 X Slope (%)	1.2		X Walk 2 X Slope (%)	N/A
			N/A	Ramp inside XWalk1?	N/A	N/A	Ramp inside XWalk2?	N/A
				Road Slope (%)	N/A	N/A	Clear Space?	N/A
				Road X Slope (%)	N/A	N/A	Clear Space to XWalk (in)	N/A
			N/A	Any Obstructions?	N/A	N/A	Storm Grate/Utility Hazard?	N/A
				Obstruction Type			Storm Grate/Utility Type	
						N/A		N/A
						Yes	Surface Condition? (G/P)	Good
Total Cost:		\$ 1850.00
