# Access Compliance Report

## Public Rights-of-Way

| Intersection ID: 5497 | Main Street: GRAYS_CREEK_LN | Cross Street: SOUTH_FORD_RD | Location: NW |
| ADA ID: D6BEC8E3D2C9 | Ramp Type: Perp | Initial Pass/Fail: Fail | Overall Compliance: No |

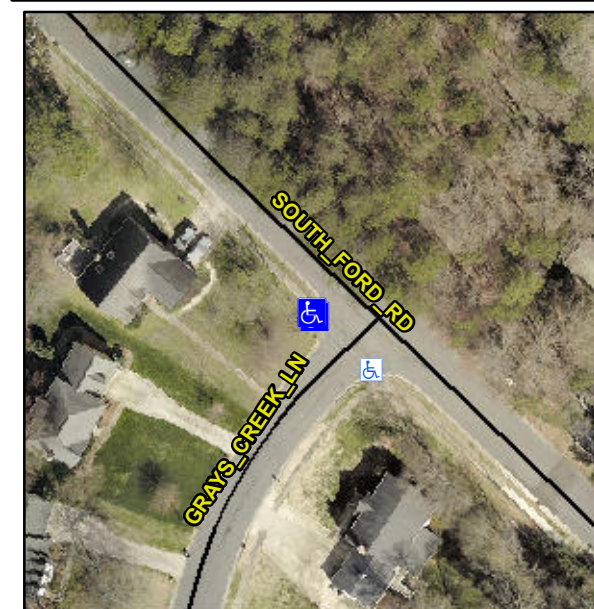
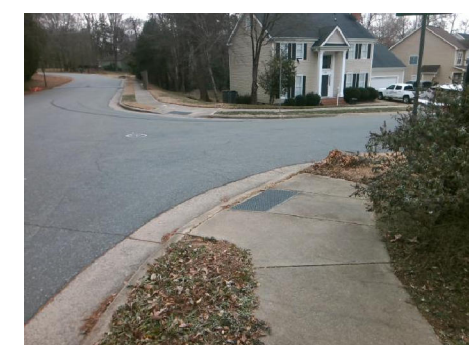
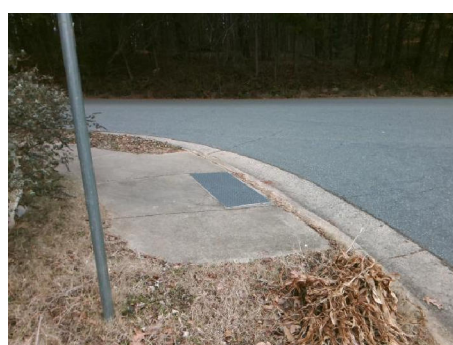
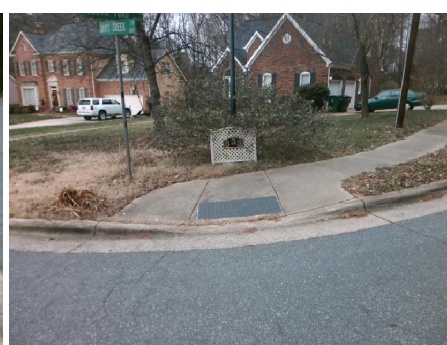
| Severity Score: 37.5 | | | |

**Not Found, R304.2.2, R304.5.3**

| Compliance | Description | Data | Compliance | Description | Data |
|---|---|---|---|---|---|
| N/A | Ramp Length (in) | 85.0 | No | Ramp Slope (%) | 10.1 |
| Yes | Ramp Width (in) | 48.0 | No | Ramp XSlope (%) | 10.0 |

**Remove & Replace Entire Ramp.**

Total Cost: \$ 1850.00
