Access Compliance Report

Public Rights-of-Way

(Curb Ramps)

Intersection ID: 31329	Main Street: DAVID_TAYLOR_DR	Cross Street: SENATOR_ROYALL_DR	Location: NE
ADA ID: D6C3AC3B50F7	Ramp Type: Perp	Initial Pass/Fail: Fail	Overall Compliance: No
		Severity Score: 1.25

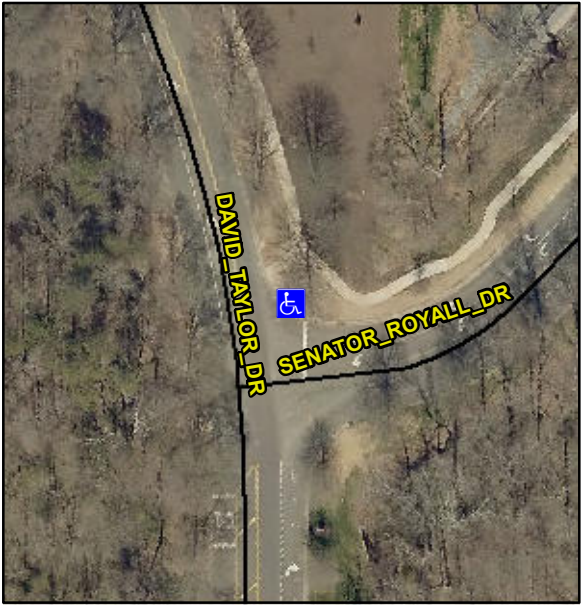
Possible Solutions:						
	Remove & Replace Entire Ramp.	N/A	Ramp Length (in)	68.5	Yes	Ramp Slope (%)	5.4
		Yes	Ramp Width (in)	72.0	No	Ramp XSlope (%)	4.8
		N/A	Flare Type LT	N/A	N/A	Flare Type RT	N/A
		N/A	Flare Slope LT (%)	N/A	N/A	Flare Slope RT (%)	N/A
		N/A	Flare Traversable LT?	N/A	N/A	Flare Traversable RT?	N/A
		N/A	Landing Length (in)	N/A	N/A	DWS Provided?	N/A
		N/A	Landing Width (in)	N/A	N/A	DWS Contrast?	N/A
		N/A	Landing Slope (%)	N/A	N/A	DWS Length (in)	N/A
		N/A	Landing X Slope (%)	N/A	N/A	DWS Full Width?	N/A
<p>Surveyor Notes:</p> <p>N/A</p> <p>PROW/ADA:</p> <p>R304.5.3</p>		N/A	Landing Curb? (Y/N)	N/A	N/A	DWS Offset (in)	N/A
		N/A	Shared Landing?	N/A			
		N/A	Gutter Ponding?	N/A	N/A	Gutter Slope (%)	N/A
		N/A	Gutter Lip Ht (in)	N/A	N/A	Gutter X Slope (%)	N/A
		N/A	Painted X Walk1?	No	N/A	Painted X Walk2?	N/A

X Walk 1 Direction	To S		X Walk 2 Direction	N/A
		N/A	X Walk 1 Width (in)	N/A	N/A	X Walk 2 Width (in)	N/A
			X Walk 1 Slope (%)	3.0		X Walk 2 Slope (%)	N/A
			X Walk 1 X Slope (%)	7.1		X Walk 2 X Slope (%)	N/A
		N/A	Ramp inside XWalk1?	N/A	N/A	Ramp inside XWalk2?	N/A
<p>Total Cost:</p> <p>\$ 1850.00</p>			Road Slope (%)	N/A	N/A	Clear Space?	N/A
			Road X Slope (%)	N/A	N/A	Clear Space to XWalk (in)	N/A
		N/A	Any Obstructions?	N/A	N/A	Storm Grate/Utility Hazard?	N/A
			Obstruction Type			Storm Grate/Utility Type	
					N/A		N/A
					Yes	Surface Condition? (G/P)	Good
