Access Compliance Report

Public Rights-of-Way (Curb Ramps)

Intersection ID: 23499	Main Street: ALEXANDER_RD	Cross Street: BROOKFIELD_PL	Location: NW
ADA ID: D6C71246E328	Ramp Type: Directional1	Initial Pass/Fail: Fail	Overall Compliance: No
		Severity Score: 12.5

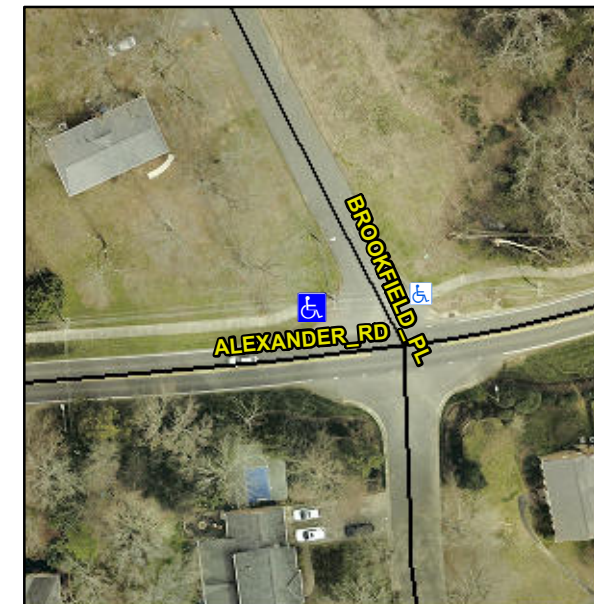
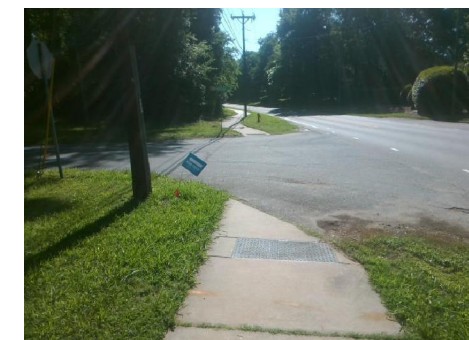
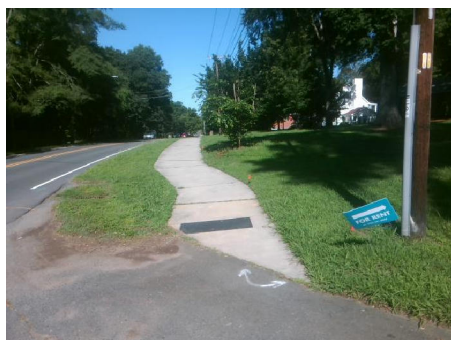
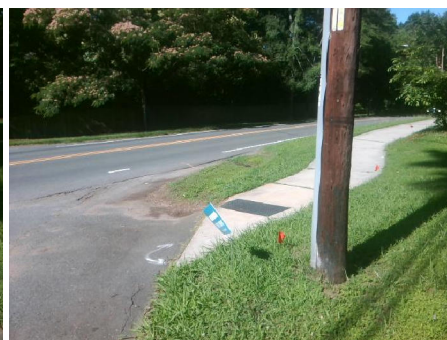
R304.5.3

Compliance	Description	Data	Compliance	Description	Data
N/A	Ramp Length (in)	48.0	N/A	Grade Break?	N/A
Yes	Ramp Width (in)	64.0	N/A	Grade Break Slope (%)	0.0
Yes	Ramp Slope (%)	2.2	N/A	Grade Break XSlope (%)	0.0
No	Ramp XSlope (%)	6.3			
N/A	Flare Type LT	N/A	N/A	Flare Type RT	N/A
N/A	Flare Slope LT (%)	N/A	N/A	Flare Slope RT (%)	0.0
N/A	Flare Traversable LT?	N/A	N/A	Flare Traversable RT?	N/A
N/A	Landing Length (in)	0.0	N/A	DWS Provided?	N/A
N/A	Landing Width (in)	0.0	N/A	DWS Contrast?	N/A
N/A	Landing Slope (%)	0.0	N/A	DWS Length (in)	N/A
N/A	Landing X Slope (%)	0.0	N/A	DWS Full Width?	N/A
N/A	Landing Curb? (Y/N)	N/A	N/A	DWS Offset LT (in)	N/A
N/A	Shared Landing?	N/A	N/A	DWS Offset RT (in)	N/A
N/A	Gutter Ponding?	0.0	N/A	Gutter Slope (%)	N/A
N/A	Gutter Lip Ht (in)	0.0	N/A	Gutter X Slope (%)	N/A
N/A	Painted X Walk1?	No		Road Slope (%)	0.4
	X Walk 1 Direction	To E		Road X Slope (%)	2.5
	X Walk 1 Width (in)	N/A		Clear Space?	N/A

X Walk 1 Slope (%)	0.4	N/A	Clear Space to XWalk (in)	N/A
	X Walk 1 X Slope (%)	2.5	N/A	Storm Grate/Utility Hazard?	N/A
N/A	Ramp inside XWalk1?	N/A		Storm Grate/Utility Type	
N/A	Any Obstructions?	N/A			N/A
	Obstruction Type		Yes	Surface Condition? (G/P)	Good
			N/A	Curb Slope (%)	6.7

Possible Solutions:

Remove & Replace Entire Ramp.
