Access Compliance Report Public Rights-of-Way (Curb Ramps)

Intersection ID: 2719 Main Street: BEAUVISTA DR Cross Street: FAIRVISTA_DR Location: NE ADA ID: D6C7E489A864 Ramp Type: PerpDiag Initial Pass/Fail: Fail **Overall Compliance: No Severity Score:** 12.5

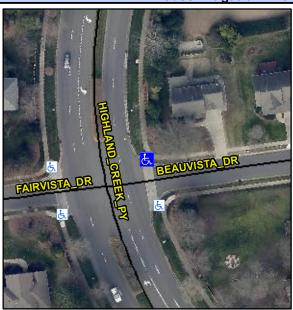
Field Measurements/Component Compliance							
	Compliance Description		Data	Compliance Description		Description	Data
	N/A	Ramp Length (in)	57.0	No	Ramp	o Slope (%)	8.6
	Yes	Ramp Width (in)	48.0	Yes	Ramp	xSlope (%)	0.6
	N/A	Flare Type LT	N/A	N/A	Flare	Type RT	N/A
	N/A	Flare Slope LT (%)	N/A	N/A	Flare	Slope RT (%)	N/A
	N/A	Flare Traversable LT?	N/A	N/A	Flare	Traversable RT?	N/A
	N/A	Landing Length (in)	N/A	N/A	DWS	Provided?	N/A
	N/A	Landing Width (in)	N/A	N/A	DWS	Contrast?	N/A
	N/A	Landing Slope (%)	N/A	N/A	DWS	Length (in)	N/A
	N/A	Landing X Slope (%)	N/A	N/A	DWS	Full Width?	N/A
	N/A	Landing Curb? (Y/N)	N/A	N/A	DWS	Offset (in)	N/A
	N/A	Shared Landing?	N/A				
	N/A	Gutter Ponding?	N/A	N/A	Gutte	er Slope (%)	N/A
	N/A	Gutter Lip Ht (in)	N/A	N/A	Gutte	er X Slope (%)	N/A
	N/A	Painted X Walk1?	No	N/A	Paint	ed X Walk2?	No
		X Walk 1 Direction	To W		X Wa	lk 2 Direction	To S
	N/A	X Walk 1 Width (in)	N/A	N/A	X Wa	ılk 2 Width (in)	N/A

X Walk 1 Slope (%)	4.5		X Wa	ılk 2 Slope (%)	0.9
		X Walk 1 X Slope (%)	1.2		X Wa	ılk 2 X Slope (%)	2.2
	N/A	Ramp inside XWalk1?	N/A	N/A	Ram	p inside XWalk2?	N/A
		Road Slope (%)	0.7	N/A	Clear	Space?	N/A
		Road X Slope (%)	1.6	N/A	Clear	Space to XWalk (in)	N/A
	N/A	Any Obstructions?	N/A	N/A	Storn	n Grate/Utility Hazard?	N/A
		Obstruction Type			Storn	n Grate/Utility Type	
			N/A				N/A
				Yes	Surfa	ice Condition? (G/P)	Good
	11/1

Possible Solutions: Remove & Replace Curb Ramp With **Two New Directional Ramps or** Equivalent. Surveyor Notes: N/A PROW/ADA: Not Found, R304.2.2
