## Access Compliance Report Public Rights-of-Way (Curb Ramps)

Intersection ID: 30402Main Street:WOODLAWN\_RDCross Street:PARK\_RD\_SHOPPING\_CENTER\_DRLocation:NWADA ID: D6D9EF1CD617Ramp Type:PerpInitial Pass/Fail:FailOverall Compliance:NoSeverity Score:37.5

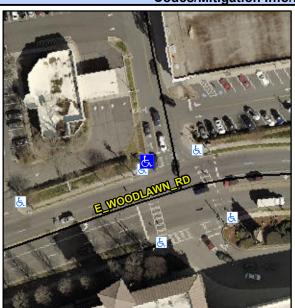
| o/Possible Solution | | | Field Measurements/Component Compliance | | | | | | |
|---|---|---|---|---|---|---|---|---|--|
| Remove & Replace Entire Ramp. | ). | N/A | Ramp Length (in) | 24.0 | No | Ramp Slope (%) | 9.0 | | |
| | • | | Yes | Ramp Width (in) | 48.0 | No | Ramp XSlope (%) | 7.9 | |
| Not Found, R304.2.2, R304.5.3 | | N/A | Gutter Lip Ht (in) | N/A | N/A | Gutter X Slope (%) | N/A | | |

| o/Possible Solution | | | Field Measurements/Component Compliance | | | | | | |
|---|---|---|---|---|---|---|---|---|--|
| Possible Solutions: | | | Comp | liance Description | Data | Comp | liance Description | Data | |
