Access Compliance Report

Public Rights-of-Way

(Curb Ramps)

Intersection ID: 7211	Main Street: KINGVILLE_DR	Cross Street: NORTHRIDGE_VILLAGE_DR	Location: NW
ADA ID: D6E38A9C3E1F	Ramp Type: BlendTrans1	Initial Pass/Fail: Fail	Overall Compliance: No
		Severity Score: 8.75

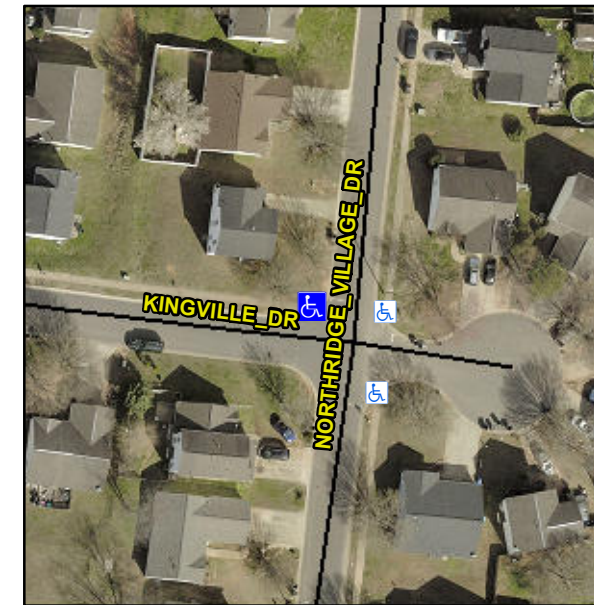
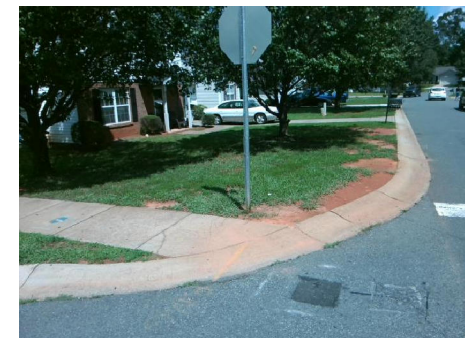
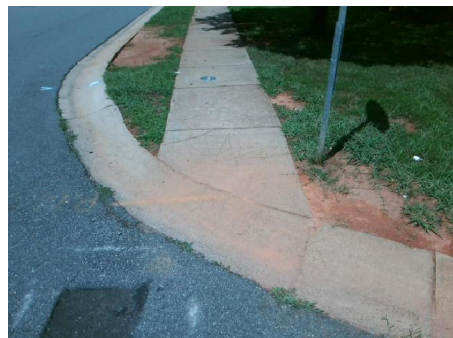
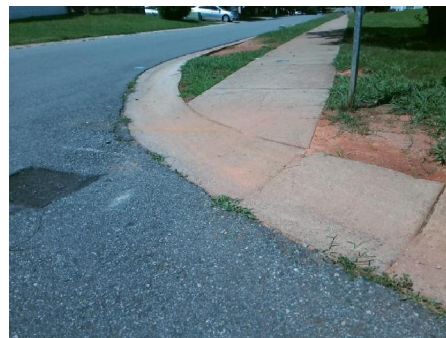
Not Found, R304.5.1

Compliance	Description	Data	Compliance	Description	Data
N/A	Ramp Length (in)	21.0	Yes	BlendTrans Slope (%)	0.4
No	Ramp Width (in)	47.5	Yes	BlendTrans XSlope (%)	1.3
N/A	Flare Type LT	N/A	N/A	Flare Type RT	N/A
N/A	Flare Slope LT (%)	N/A	N/A	Flare Slope RT (%)	N/A
N/A	Flare Traversable LT?	N/A	N/A	Flare Traversable RT?	N/A
N/A	Landing Length (in)	N/A	N/A	DWS Provided?	N/A
N/A	Landing Width (in)	N/A	N/A	DWS Contrast?	N/A
N/A	Landing Slope (%)	N/A	N/A	DWS Length (in)	N/A
N/A	Landing X Slope (%)	N/A	N/A	DWS Full Width?	N/A
N/A	Landing Curb? (Y/N)	N/A	N/A	DWS Offset (in)	N/A
N/A	Shared Landing?	N/A			
N/A	Gutter Ponding?	N/A	N/A	Gutter Slope (%)	N/A
N/A	Gutter Lip Ht (in)	N/A	N/A	Gutter X Slope (%)	N/A
N/A	Painted X Walk1?	No	N/A	Painted X Walk2?	N/A
	X Walk 1 Direction	To E		X Walk 2 Direction	N/A
	X Walk 1 Width (in)	N/A		X Walk 2 Width (in)	N/A
	X Walk 1 Slope (%)	1.9		X Walk 2 Slope (%)	N/A
	X Walk 1 X Slope (%)	0.3		X Walk 2 X Slope (%)	N/A

N/A	Ramp inside XWalk1?	N/A	N/A	Ramp inside XWalk2?	N/A
	Road Slope (%)	0.3		Clear Space?	N/A
	Road X Slope (%)	1.9	N/A	Clear Space to XWalk (in)	N/A
N/A	Any Obstructions?	N/A	N/A	Storm Grate/Utility Hazard?	N/A
	Obstruction Type			Storm Grate/Utility Type	
		N/A			N/A
			Yes	Surface Condition? (G/P)	Good
			No	Curb Slope (%)	11.0

Remove & Replace Curb Ramp With Two New Directional Ramps or Equivalent.
