Access Compliance Report Public Rights-of-Way (Curb Ramps)

Intersection ID: 46180	Main Street: SWEETSPIRE_RD			Cross Street: SEVEN_OAKS_DR				Location:	E	
ADA ID: D6E436D973EC	Ramp Ty	Ramp Type: PerpDiag			Initial Pass/Fail: Fail Overall Compliance:			o Severity Score:	10	
Codes/Mitigation Info/Possible Solution					Field Measurements/Component Compliance

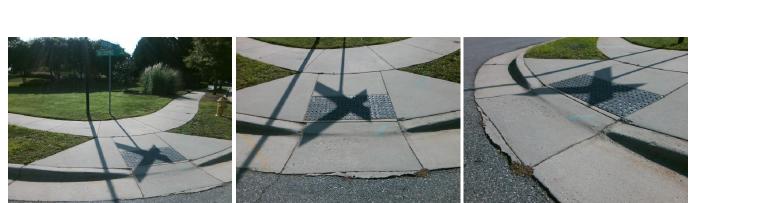
1. 1. 1.	Possible Solutions:		Compliance Description			Data Compliance Description			
		Remove & Replace Curb Ran	Ramp With	N/A	Ramp Length (in)	59.5	Yes	Ramp Slope (%)	5.2	
a table of a table	1. 1/1	Two New Directional Ramps	•	No	Ramp Width (in)	47.0	No	Ramp XSlope (%)	2.8	
		Equivalent.		N/A	Flare Type LT	N/A	N/A	Flare Type RT	N/A	
Contraction of the second	C3 ¹²¹			N/A	Flare Slope LT (%)	N/A	N/A	Flare Slope RT (%)	N/A	
	SEPT /			N/A	Flare Traversable LT?	N/A	N/A	Flare Traversable RT?	N/A	
				N/A	Landing Length (in)	N/A	N/A	DWS Provided?	N/A	
6		Surveyor Notes:		N/A	Landing Width (in)	N/A	N/A	DWS Contrast?	N/A	
	State (State 1)	N/A		N/A	Landing Slope (%)	N/A	N/A	DWS Length (in)	N/A	
the second secon	· · · · · · · · · · · · · · · · · · ·			N/A	Landing X Slope (%)	N/A	N/A	DWS Full Width?	N/A	
	A Calman /			N/A	Landing Curb? (Y/N)	N/A	N/A	DWS Offset (in)	N/A	
	N HOLER	2		N/A	Shared Landing?	N/A

The second of the	THE REAL	PROW/ADA:		N/A	Gutter Ponding?	N/A	N/A	Gutter Slope (%)	N/A	
Sec. 11	1110/	Not Found, R304.5.1, R304.5.3	3	N/A	Gutter Lip Ht (in)	N/A	N/A	Gutter X Slope (%)	N/A	
	5		•	N/A	Painted X Walk1?	No	N/A	Painted X Walk2?	No
