# Access Compliance Report

## Public Rights-of-Way (Curb Ramps)

| Intersection ID: N/A | Main Street: DIXIE_RIVER_RD | Cross Street: N/A | Location: NE |
| ADA ID: D6E43965C855 | Ramp Type: BlendTrans1 | Initial Pass/Fail: Pass | Overall Compliance: No |

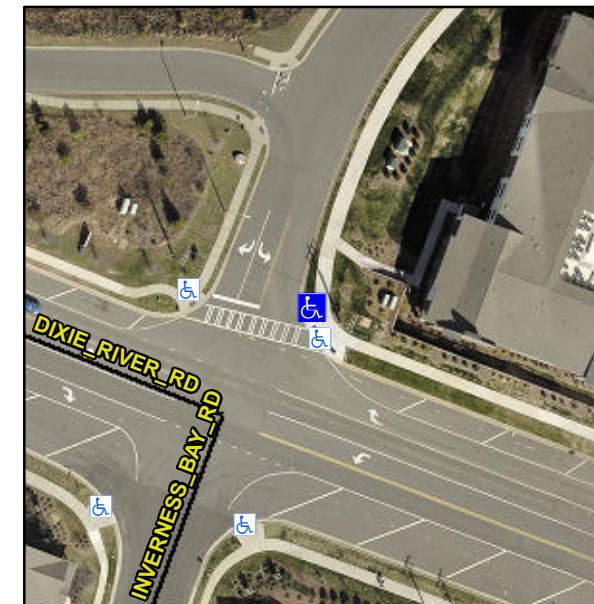
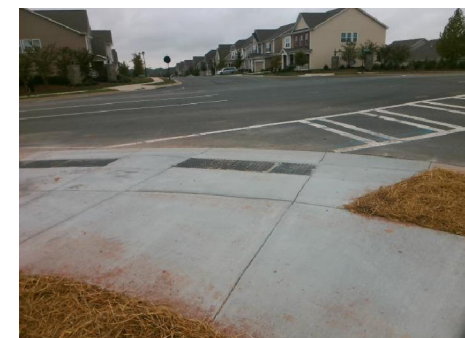
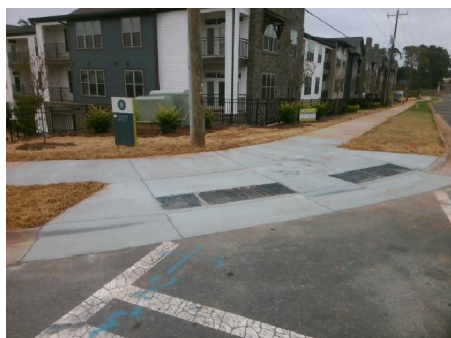
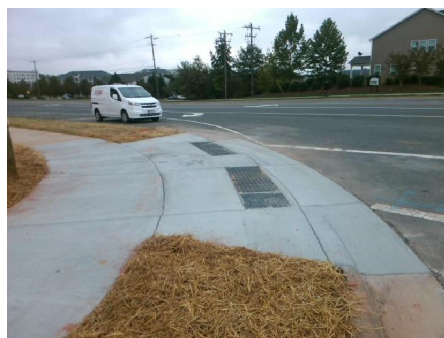
Possible Solutions:

**R305.2**

| Compliance | Description | Data | Compliance | Description | Data |
|---|---|---|---|---|---|
| N/A | Landing Curb? (Y/N) | No | No | DWS Offset (in) | 4.0 |

**Remove & Replace Detectable Warning System.**
