## Access Compliance Report Public Rights-of-Way (Curb Ramps)

Intersection ID: 3556 Main Street: PROSPERITY\_CHURCH\_RD Cross Street: WHITE\_CASCADE\_DR Location: S

ADA ID: D6F5139ACA04 Ramp Type: Perp Initial Pass/Fail: Fail Overall Compliance: No Severity Score: 42.5

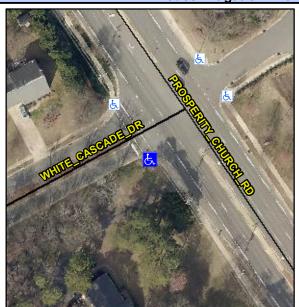
R304.5.1, R304.2.2, R304.5.3

Field Measurements/Component Compliance						
	Compliance Description		Data	Compliance Description		Data
	N/A	Ramp Length (in)	72.0	No	Ramp Slope (%)	8.6
	No	Ramp Width (in)	33.5	No	Ramp XSlope (%)	5.7
	N/A	Flare Type LT	N/A	N/A	Flare Type RT	N/A
	N/A	Flare Slope LT (%)	N/A	N/A	Flare Slope RT (%)	N/A
	N/A	Flare Traversable LT?	N/A	N/A	Flare Traversable RT?	N/A
	N/A	Landing Length (in)	N/A	N/A	DWS Provided?	N/A
	N/A	Landing Width (in)	N/A	N/A	DWS Contrast?	N/A
	N/A	Landing Slope (%)	N/A	N/A	DWS Length (in)	N/A
	N/A	Landing X Slope (%)	N/A	N/A	DWS Full Width?	N/A
	N/A	Landing Curb? (Y/N)	N/A	N/A	DWS Offset (in)	N/A
	N/A	Shared Landing?	N/A			
	N/A	Gutter Ponding?	N/A	N/A	Gutter Slope (%)	N/A
	N/A	Gutter Lip Ht (in)	N/A	N/A	Gutter X Slope (%)	N/A
	N/A	Painted X Walk1?	Yes	N/A	Painted X Walk2?	N/A
		X Walk 1 Direction	To NW		X Walk 2 Direction	N/A
	N/A	X Walk 1 Width (in)	98.0	N/A	X Walk 2 Width (in)	N/A
		X Walk 1 Slope (%)	0.1		X Walk 2 Slope (%)	N/A

X Walk 1 X Slope (%)	4.8		X Walk 2 X Slope (%)	N/A
	N/A	Ramp inside XWalk1?	Yes	N/A	Ramp inside XWalk2?	N/A
		Road Slope (%)	N/A	N/A	Clear Space?	N/A
		Road X Slope (%)	N/A	N/A	Clear Space to XWalk (in)	N/A
	N/A	Any Obstructions?	N/A	N/A	Storm Grate/Utility Hazard?	N/A
		Obstruction Type			Storm Grate/Utility Type	
			N/A			N/A
				Yes	Surface Condition? (G/P)	Good
	The state of the

Remove & Replace Entire Ramp.

Total Cost: \$ 1850.00
