Access Compliance Report Public Rights-of-Way (Curb Ramps)

Intersection ID: 19600 Main Street: SCOFIELD_RD **Cross Street: WINTERCREST_LN** Location: **Overall Compliance: No** Severity Score: 13.75 ADA ID: D7042FA1500D Ramp Type: Directional1 Initial Pass/Fail: Fail

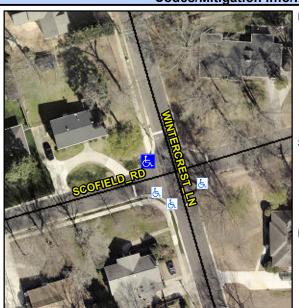
Field Measurements/Component Compliance							
Compl	iance Description	Data	Comp	liance Description	Data		
N/A	Ramp Length (in)	232.0	N/A	Grade Break?	N/A		
Yes	Ramp Width (in)	58.5	N/A	Grade Break Slope (%)	0.0		
Yes	Ramp Slope (%)	11.8	N/A	Grade Break XSlope (%)	0.0		
No	Ramp XSlope (%)	3.7					
N/A	Flare Type LT	N/A	N/A	Flare Type RT	N/A		
N/A	Flare Slope LT (%)	N/A	N/A	Flare Slope RT (%)	0.0		
N/A	Flare Traversable LT?	N/A	N/A	Flare Traversable RT?	N/A		
N/A	Landing Length (in)	0.0	N/A	DWS Provided?	N/A		
N/A	Landing Width (in)	0.0	N/A	DWS Contrast?	N/A		
N/A	Landing Slope (%)	0.0	N/A	DWS Length (in)	N/A		
N/A	Landing X Slope (%)	0.0	N/A	DWS Full Width?	N/A		
N/A	Landing Curb? (Y/N)	N/A	N/A	DWS Offset LT (in)	N/A		
N/A	Shared Landing?	N/A	N/A	DWS Offset RT (in)	N/A		
N/A	Gutter Ponding?	0.0	N/A	Gutter Slope (%)	N/A		
N/A	Gutter Lip Ht (in)	0.0	N/A	Gutter X Slope (%)	N/A		
N/A	Painted X Walk1?	No		Road Slope (%)	4.6

X Walk 1 Direction	To S		Road X Slope (%)	5.2		
	X Walk 1 Width (in)	N/A		Clear Space?	N/A		
	X Walk 1 Slope (%)	4.6	N/A	Clear Space to XWalk (in)	N/A		
	X Walk 1 X Slope (%)	5.2	N/A	Storm Grate/Utility Hazard?	N/A		
N/A	Ramp inside XWalk1?	N/A		Storm Grate/Utility Type			
N/A	Any Obstructions?	N/A			N/A		
	Obstruction Type		Yes	Surface Condition? (G/P)	Good		
		N/A	N/A	Curb Slope (%)	12.0

Possible Solutions:	9
Remove & Replace Entire Ramp.	
·	١
	Y
	N
	1
	N
Surveyor Notes:	N
N/A	1
	N
	1
	1
PROW/ADA:	1
R304.5.3	N
	1
	ı
	N
