Access Compliance Report Public Rights-of-Way (Curb Ramps)

Intersection ID: 27325 Main Street: TILLEY_MORRIS_RD Cross Street: N/A Location: SE

ADA ID: D70C0B3F3679 Ramp Type: Perp Initial Pass/Fail: Fail Overall Compliance: No Severity Score: 1.25

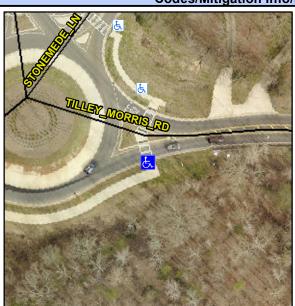
Field Measurements/Component Compliance Compliance Description Data Compliance Description D					
N/A	Ramp Length (in)	96.0	Yes	Ramp Slope (%)	6.5
Yes	Ramp Width (in)	117.0	No	Ramp XSlope (%)	2.9
N/A	Flare Type LT	N/A	N/A	Flare Type RT	N/A
N/A	Flare Slope LT (%)	N/A	N/A	Flare Slope RT (%)	N/A
N/A	Flare Traversable LT?	N/A	N/A	Flare Traversable RT?	N/A
N/A	Landing Length (in)	N/A	N/A	DWS Provided?	N/A
N/A	Landing Width (in)	N/A	N/A	DWS Contrast?	N/A
N/A	Landing Slope (%)	N/A	N/A	DWS Length (in)	N/A
N/A	Landing X Slope (%)	N/A	N/A	DWS Full Width?	N/A
N/A	Landing Curb? (Y/N)	N/A	N/A	DWS Offset (in)	N/A
N/A	Shared Landing?	N/A			
N/A	Gutter Ponding?	N/A	N/A	Gutter Slope (%)	N/A
N/A	Gutter Lip Ht (in)	N/A	N/A	Gutter X Slope (%)	N/A
N/A	Painted X Walk1?	Yes	N/A	Painted X Walk2?	N/A
	X Walk 1 Direction	To N		X Walk 2 Direction	N/A
N/A	X Walk 1 Width (in)	112.0	N/A	X Walk 2 Width (in)	N/A
	X Walk 1 Slope (%)	11.2		X Walk 2 Slope (%)	N/A

X Walk 1 X Slope (%)	4.8		X Walk 2 X Slope (%)	N/A
N/A	Ramp inside XWalk1?	Yes	N/A	Ramp inside XWalk2?	N/A
	Road Slope (%)	N/A	N/A	Clear Space?	N/A
	Road X Slope (%)	N/A	N/A	Clear Space to XWalk (in)	N/A
N/A	Any Obstructions?	N/A	N/A	Storm Grate/Utility Hazard?	N/A
	Obstruction Type			Storm Grate/Utility Type	
		N/A			N/A
			Yes	Surface Condition? (G/P)	Good

Possible Solution		
Possible Solutions:	<u>c</u>	
Remove & Replace Entire Ramp.		
	Υ	
	N	
	N	
	N	
	N	
Surveyor Notes:	N	
N/A	N	
	N	
	N	
	N	
PROW/ADA:	N	
Not Found, R304.5.3	N	
,	N	
	N
