Access Compliance Report Public Rights-of-Way (Curb Ramps)

Intersection ID: 50325 Main Street: FITCHBURG_CT **Cross Street: SHARPES_CR** Location: NE **Overall Compliance: No ADA ID: D712393AEEBE** Ramp Type: Perp Initial Pass/Fail: Fail **Severity Score:** 10

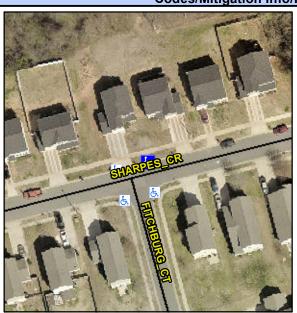
Field Measurements/Component Compliance								
Comp	liance Description	Data	Complia	nce	Description	Data		
N/A	Ramp Length (in)	48.5	Yes	Ramp	Slope (%)	5.3		
No	Ramp Width (in)	47.5	Yes	Yes Ramp XSlope (%)		4.3		
N/A	Flare Type LT	N/A	N/A	N/A Flare Type RT		N/A		
N/A	Flare Slope LT (%)	N/A	N/A	N/A Flare Slope RT (%)		N/A		
N/A	Flare Traversable LT?	N/A	N/A	N/A Flare Traversable RT?		N/A		
N/A	Landing Length (in)	N/A	N/A	DWS	Provided?	N/A		
N/A	Landing Width (in)	N/A	N/A	DWS	Contrast?	N/A		
N/A	Landing Slope (%)	N/A	N/A	DWS	Length (in)	N/A		
N/A	Landing X Slope (%)	N/A	N/A	DWS	Full Width?	N/A		
N/A	Landing Curb? (Y/N)	N/A	N/A	DWS	Offset (in)	N/A		
N/A	Shared Landing?	N/A						
N/A	Gutter Ponding?	N/A	N/A	Gutte	r Slope (%)	N/A		
N/A	Gutter Lip Ht (in)	1.0	N/A	Gutte	r X Slope (%)	N/A		
N/A	Painted X Walk1?	No	N/A	Painte	ed X Walk2?	N/A		
	X Walk 1 Direction	To S		X Wal	k 2 Direction	N/A		
N/A	X Walk 1 Width (in)	N/A	N/A	X Wal	k 2 Width (in)	N/A

X Walk 1 Slope (%)	0.6		X Wal	k 2 Slope (%)	N/A		
	X Walk 1 X Slope (%)	4.5		X Wal	k 2 X Slope (%)	N/A		
N/A	Ramp inside XWalk1?	N/A	N/A	Ramp	inside XWalk2?	N/A		
	Road Slope (%)	N/A	N/A	Clear	Space?	N/A		
	Road X Slope (%)	N/A	N/A	Clear	Space to XWalk (in)	N/A		
N/A	Any Obstructions?	N/A	N/A	Storm	Grate/Utility Hazard?	N/A		
	Obstruction Type		Storm Grate/Utility Type					
		N/A				N/A		
			Yes	Surfac	ce Condition? (G/P)	Good

/Possible Solution	
Possible Solutions:	Col
Remove & Replace Entire Ramp.	N/A
·	No
	N/A
	N/A
	N/A
	N/A
Surveyor Notes:	N/A
N/A	N/A
	N/A
	N/A
	N/A
PROW/ADA:	N/A
Not Found, R304.5.1	N/A
,	N/A
	N/A
