Access Compliance Report

Public Rights-of-Way

(Curb Ramps)

Intersection ID: N/A	Main Street: BISHOP_CREST_LN	Cross Street: BLAKENEY_PROFESSIONAL_DR	Location: NW
ADA ID: D717A33CEC52	Ramp Type: PerpDiag	Initial Pass/Fail: Fail	Overall Compliance: No
			Severity Score: 21.25

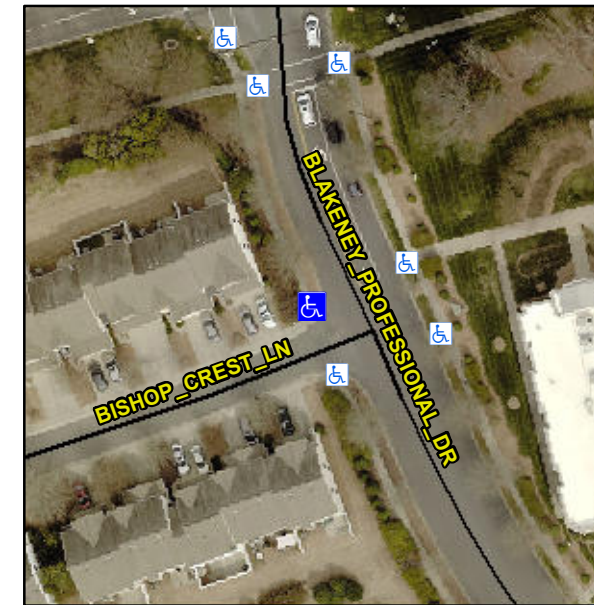
R304.5.1, R304.5.3

Compliance	Description	Data	Compliance	Description	Data
N/A	Ramp Length (in)	75.0	Yes	Ramp Slope (%)	7.2
No	Ramp Width (in)	47.0	No	Ramp XSlope (%)	5.8
N/A	Flare Type LT	N/A	N/A	Flare Type RT	N/A
N/A	Flare Slope LT (%)	N/A	N/A	Flare Slope RT (%)	N/A
N/A	Flare Traversable LT?	N/A	N/A	Flare Traversable RT?	N/A
N/A	Landing Length (in)	N/A	N/A	DWS Provided?	N/A
N/A	Landing Width (in)	N/A	N/A	DWS Contrast?	N/A
N/A	Landing Slope (%)	N/A	N/A	DWS Length (in)	N/A
N/A	Landing X Slope (%)	N/A	N/A	DWS Full Width?	N/A
N/A	Landing Curb? (Y/N)	N/A	N/A	DWS Offset (in)	N/A
N/A	Shared Landing?	N/A			
N/A	Gutter Ponding?	N/A	N/A	Gutter Slope (%)	N/A
N/A	Gutter Lip Ht (in)	N/A	N/A	Gutter X Slope (%)	N/A
N/A	Painted X Walk1?	No	N/A	Painted X Walk2?	No
	X Walk 1 Direction	To S		X Walk 2 Direction	To E
N/A	X Walk 1 Width (in)	N/A	N/A	X Walk 2 Width (in)	N/A
	X Walk 1 Slope (%)	1.6		X Walk 2 Slope (%)	4.1
	X Walk 1 X Slope (%)	0.8		X Walk 2 X Slope (%)	1.8

N/A	Ramp inside XWalk1?	N/A	N/A	Ramp inside XWalk2?	N/A
	Road Slope (%)	1.8	N/A	Clear Space?	N/A
	Road X Slope (%)	0.4	N/A	Clear Space to XWalk (in)	N/A
N/A	Any Obstructions?	N/A	N/A	Storm Grate/Utility Hazard?	N/A
	Obstruction Type			Storm Grate/Utility Type	
		N/A			N/A
			Yes	Surface Condition? (G/P)	Good

Remove & Replace Curb Ramp With Two New Directional Ramps or Equivalent.
