# Access Compliance Report

## Public Rights-of-Way

| Intersection ID: 7478 | Main Street: STONEHURST_DR | Cross Street: SULLINS_RD | Location: | N/A |
| ADA ID: D71CF0619445 | Ramp Type: Perp | Initial Pass/Fail: Fail | Overall Compliance: No | Severity Score: 12.5 |

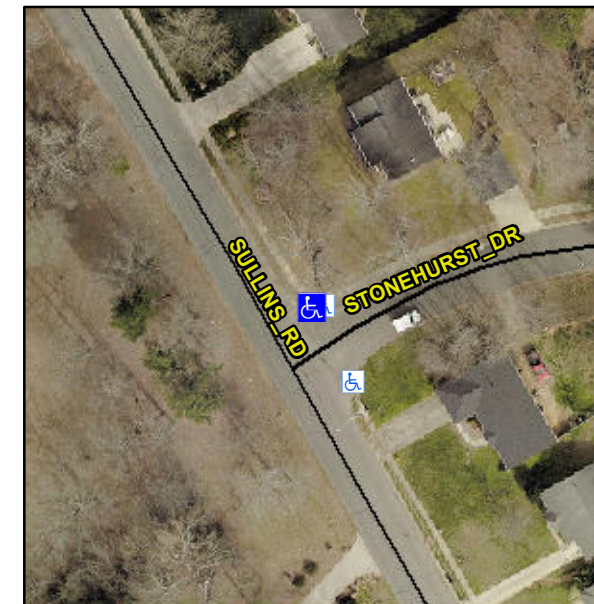
**Not Found, R304.2.2**

| Compliance | Description | Data | Compliance | Description | Data |
|---|---|---|---|---|---|
| N/A | Ramp Length (in) | 48.0 | No | Ramp Slope (%) | 9.4 |
| Yes | Ramp Width (in) | 48.0 | Yes | Ramp XSlope (%) | 1.6 |

**Remove & Replace Entire Ramp.**

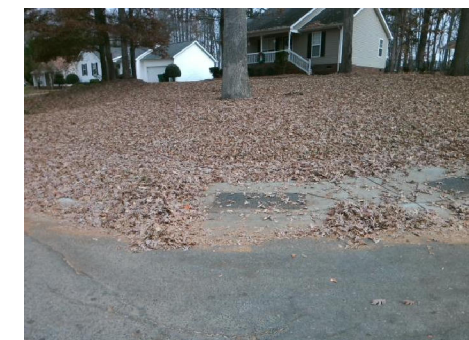
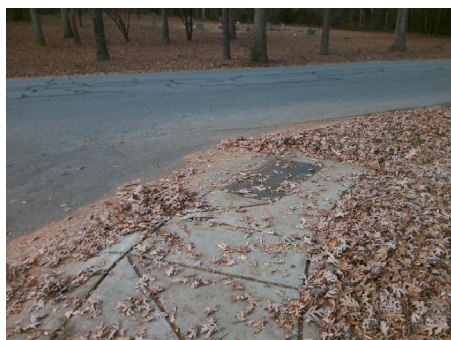
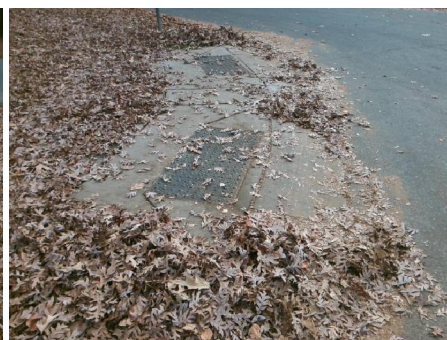
| Compliance | Description | Data | Compliance | Description | Data |
|---|---|---|---|---|---|
| | | | Yes | Surface Condition? (G/P) | Good |
