Access Compliance Report

Public Rights-of-Way

(Curb Ramps)

Intersection ID: 27494	Main Street: BALLANTYNE COMMONS PY	Cross Street: SUMMIT COMMONS BV	Location: SW
ADA ID: D71ECD4FD56A	Ramp Type: Perp	Initial Pass/Fail: Fail	Overall Compliance: No
Severity Score: 12.5			
Codes/Mitigation Info/Possible Solution		Field Measurements/Component Compliance

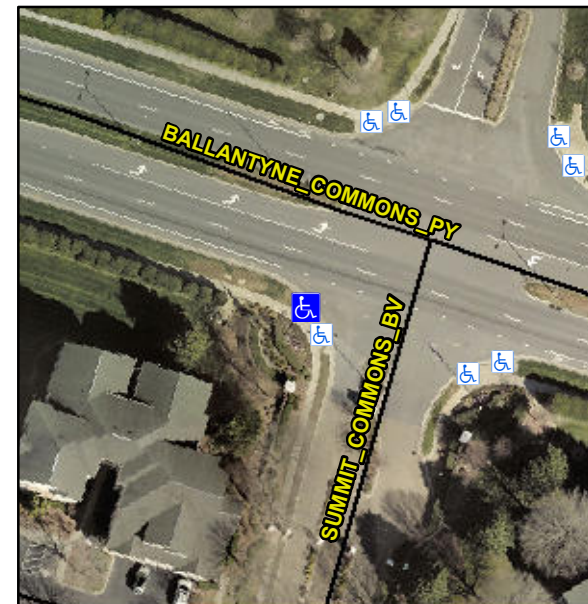
Compliance	Description	Data	Compliance	Description	Data
N/A	Ramp Length (in)	131.0	Yes	Ramp Slope (%)	5.7
Yes	Ramp Width (in)	51.0	No	Ramp XSlope (%)	6.1
N/A	Flare Type LT	N/A	N/A	Flare Type RT	N/A
N/A	Flare Slope LT (%)	N/A	N/A	Flare Slope RT (%)	N/A
N/A	Flare Traversable LT?	N/A	N/A	Flare Traversable RT?	N/A
N/A	Landing Length (in)	N/A	N/A	DWS Provided?	N/A
N/A	Landing Width (in)	N/A	N/A	DWS Contrast?	N/A
N/A	Landing Slope (%)	N/A	N/A	DWS Length (in)	N/A
N/A	Landing X Slope (%)	N/A	N/A	DWS Full Width?	N/A
N/A	Landing Curb? (Y/N)	N/A	N/A	DWS Offset (in)	N/A
N/A	Shared Landing?	N/A			
N/A	Gutter Ponding?	N/A	N/A	Gutter Slope (%)	N/A
N/A	Gutter Lip Ht (in)	N/A	N/A	Gutter X Slope (%)	N/A
N/A	Painted X Walk1?	No	N/A	Painted X Walk2?	N/A
	X Walk 1 Direction	To NE		X Walk 2 Direction	N/A
N/A	X Walk 1 Width (in)	N/A	N/A	X Walk 2 Width (in)	N/A
	X Walk 1 Slope (%)	1.5		X Walk 2 Slope (%)	N/A
	X Walk 1 X Slope (%)	5.2		X Walk 2 X Slope (%)	N/A

N/A	Ramp inside XWalk1?	N/A	N/A	Ramp inside XWalk2?	N/A
	Road Slope (%)	N/A	N/A	Clear Space?	N/A
	Road X Slope (%)	N/A	N/A	Clear Space to XWalk (in)	N/A
N/A	Any Obstructions?	N/A	N/A	Storm Grate/Utility Hazard?	N/A
	Obstruction Type			Storm Grate/Utility Type	
		N/A			N/A
			Yes	Surface Condition? (G/P)	Good

Possible Solutions:

Remove & Replace Entire Ramp.
