Access Compliance Report

Public Rights-of-Way

(Curb Ramps)

Intersection ID: 10021176	Main Street: BILLINGSLEY_RD	Cross Street: N/A	Location: SE
ADA ID: D720A6AD31E8	Ramp Type: PerpDiag	Initial Pass/Fail: Fail	Overall Compliance: No
Severity Score: 12.5			
Codes/Mitigation Info/Possible Solution		Field Measurements/Component Compliance

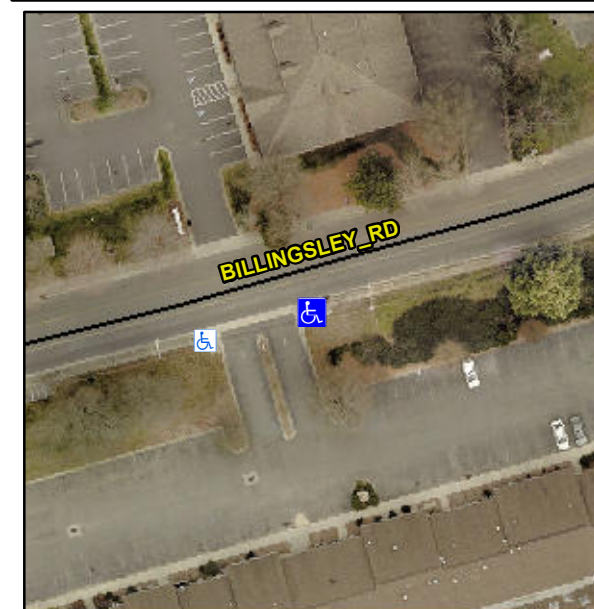
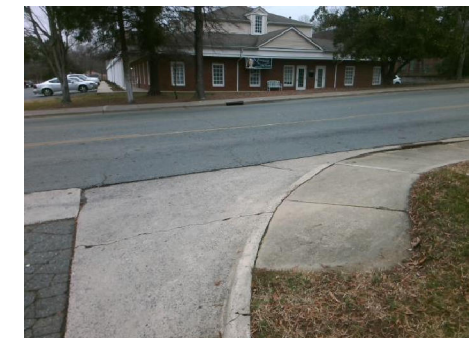
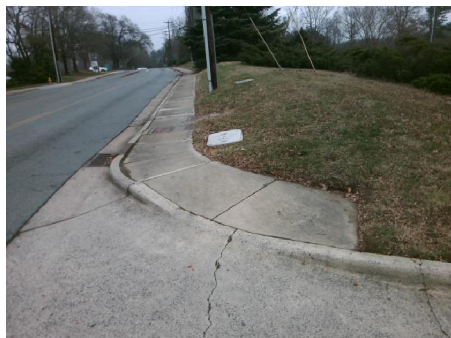
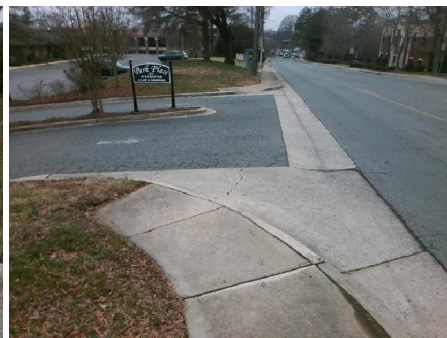
Not Found, R304.5.3

Compliance	Description	Data	Compliance	Description	Data
N/A	Ramp Length (in)	52.0	Yes	Ramp Slope (%)	6.7
Yes	Ramp Width (in)	48.0	No	Ramp XSlope (%)	5.6
N/A	Flare Type LT	N/A	N/A	Flare Type RT	N/A
N/A	Flare Slope LT (%)	N/A	N/A	Flare Slope RT (%)	N/A
N/A	Flare Traversable LT?	N/A	N/A	Flare Traversable RT?	N/A
N/A	Landing Length (in)	N/A	N/A	DWS Provided?	N/A
N/A	Landing Width (in)	N/A	N/A	DWS Contrast?	N/A
N/A	Landing Slope (%)	N/A	N/A	DWS Length (in)	N/A
N/A	Landing X Slope (%)	N/A	N/A	DWS Full Width?	N/A
N/A	Landing Curb? (Y/N)	N/A	N/A	DWS Offset (in)	N/A
N/A	Shared Landing?	N/A			
N/A	Gutter Ponding?	N/A	N/A	Gutter Slope (%)	N/A
N/A	Gutter Lip Ht (in)	N/A	N/A	Gutter X Slope (%)	N/A
N/A	Painted X Walk1?	No	N/A	Painted X Walk2?	No
	X Walk 1 Direction	To N		X Walk 2 Direction	To W
N/A	X Walk 1 Width (in)	N/A	N/A	X Walk 2 Width (in)	N/A
	X Walk 1 Slope (%)	8.4		X Walk 2 Slope (%)	6.0
	X Walk 1 X Slope (%)	6.3		X Walk 2 X Slope (%)	1.4

N/A	Ramp inside XWalk1?	N/A	N/A	Ramp inside XWalk2?	N/A
	Road Slope (%)	3.6	N/A	Clear Space?	N/A
	Road X Slope (%)	11.5	N/A	Clear Space to XWalk (in)	N/A
N/A	Any Obstructions?	N/A	N/A	Storm Grate/Utility Hazard?	N/A
	Obstruction Type			Storm Grate/Utility Type	
		N/A			N/A
			Yes	Surface Condition? (G/P)	Good

Possible Solutions:

Remove & Replace Curb Ramp With Two New Directional Ramps or Equivalent.
