Access Compliance Report

Public Rights-of-Way

(Curb Ramps)

Intersection ID: 9295	Main Street: MILES_CT	Cross Street: ORVIS_ST	Location: NE
ADA ID: D7236280D6B3	Ramp Type: Perp	Initial Pass/Fail: Fail	Overall Compliance: No
Severity Score: 8.75			
Codes/Mitigation Info/Possible Solution		Field Measurements/Component Compliance

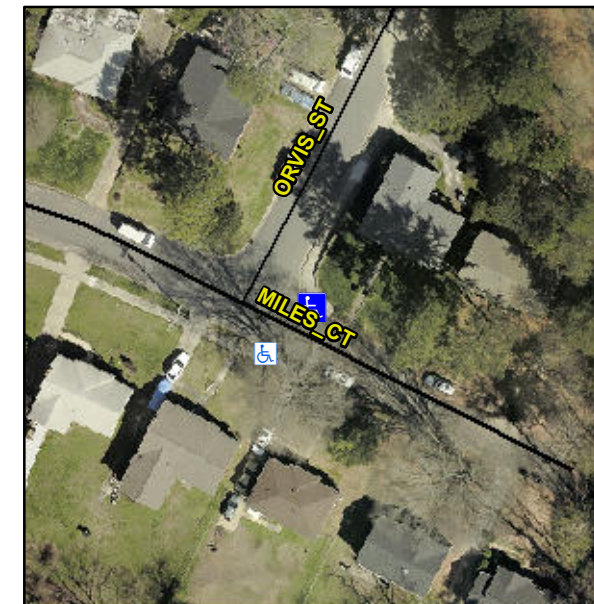
Not Found, R304.5.1

Compliance	Description	Data	Compliance	Description	Data
N/A	Ramp Length (in)	76.0	Yes	Ramp Slope (%)	6.8
No	Ramp Width (in)	47.0	Yes	Ramp XSlope (%)	0.3
N/A	Flare Type LT	N/A	N/A	Flare Type RT	N/A
N/A	Flare Slope LT (%)	N/A	N/A	Flare Slope RT (%)	N/A
N/A	Flare Traversable LT?	N/A	N/A	Flare Traversable RT?	N/A
N/A	Landing Length (in)	N/A	N/A	DWS Provided?	N/A
N/A	Landing Width (in)	N/A	N/A	DWS Contrast?	N/A
N/A	Landing Slope (%)	N/A	N/A	DWS Length (in)	N/A
N/A	Landing X Slope (%)	N/A	N/A	DWS Full Width?	N/A
N/A	Landing Curb? (Y/N)	N/A	N/A	DWS Offset (in)	N/A
N/A	Shared Landing?	N/A			
N/A	Gutter Ponding?	N/A	N/A	Gutter Slope (%)	N/A
N/A	Gutter Lip Ht (in)	N/A	N/A	Gutter X Slope (%)	N/A
N/A	Painted X Walk1?	No	N/A	Painted X Walk2?	N/A
	X Walk 1 Direction	To S		X Walk 2 Direction	N/A
N/A	X Walk 1 Width (in)	N/A	N/A	X Walk 2 Width (in)	N/A
	X Walk 1 Slope (%)	1.9		X Walk 2 Slope (%)	N/A
	X Walk 1 X Slope (%)	1.7		X Walk 2 X Slope (%)	N/A

N/A	Ramp inside XWalk1?	N/A	N/A	Ramp inside XWalk2?	N/A
	Road Slope (%)	N/A	N/A	Clear Space?	N/A
	Road X Slope (%)	N/A	N/A	Clear Space to XWalk (in)	N/A
N/A	Any Obstructions?	N/A	N/A	Storm Grate/Utility Hazard?	N/A
	Obstruction Type			Storm Grate/Utility Type	
		N/A			N/A
		Yes		Surface Condition? (G/P)	Good

Possible Solutions:

Remove & Replace Entire Ramp.
