# Access Compliance Report

## Public Rights-of-Way

| Intersection ID: 16040 | Main Street: GREYSTONE_RD | Cross Street: MAYFIELD_AV | Location: NW |
| ADA ID: D7340406627B | Ramp Type: PerpDiag | Initial Pass/Fail: Pass | Overall Compliance: No |

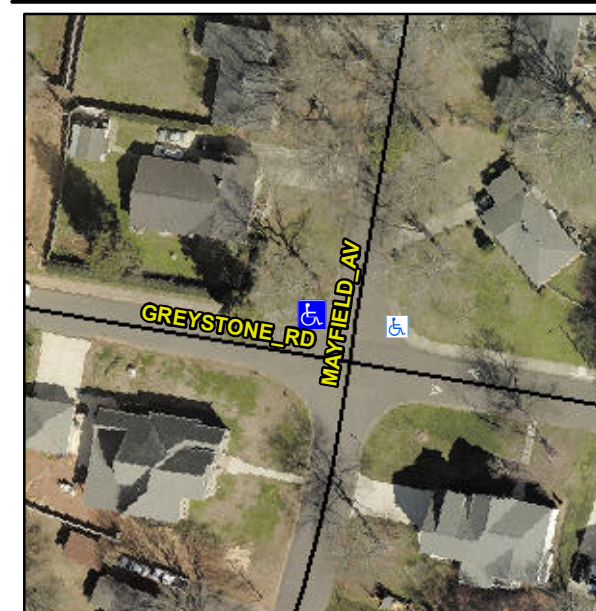
**Not Found, R304.5.3, R304.2.1, R304.2.2-Perp, R304.3.2-Para, R305.2**

| Compliance | Description | Data | Compliance | Description | Data |
|---|---|---|---|---|---|
| Yes | Ramp Width (in) | 48.0 | No | Ramp XSlope (%) | 2.5 |
| No | Landing Length (in) | N/A | Yes | DWS Provided? | Yes |
| No | Landing Width (in) | N/A | Yes | DWS Contrast? | Yes |
| No | Landing Slope (%) | N/A | Yes | DWS Length (in) | 25.0 |
| No | Landing X Slope (%) | N/A | Yes | DWS Full Width? | Yes |
| N/A | Landing Curb? (Y/N) | No | No | DWS Offset (in) | 4.0 |

**Remove & Replace Curb Ramp With Two New Directional Ramps or Equivalent.**

Total Cost: \$ 3200.00
