Access Compliance Report

Public Rights-of-Way

(Curb Ramps)

Intersection ID: N/A	Main Street: CENTER PARK DR	Cross Street: GREENPARK_CIR	Location: NW
ADA ID: D73A5376FEAE	Ramp Type: PerpDiag	Initial Pass/Fail: Fail	Overall Compliance: No
		Severity Score: 25

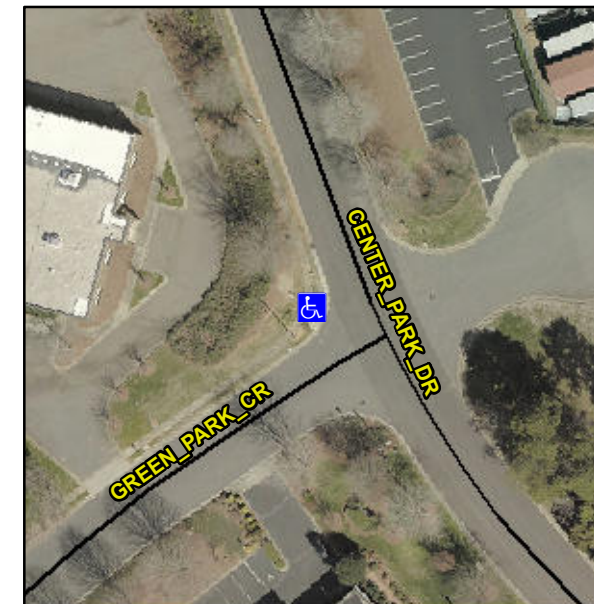
Compliance	Description	Data	Compliance	Description	Data
N/A	Ramp Length (in)	89.0	No	Ramp Slope (%)	8.8
Yes	Ramp Width (in)	50.0	No	Ramp XSlope (%)	5.5
N/A	Flare Type LT	N/A	N/A	Flare Type RT	N/A
N/A	Flare Slope LT (%)	N/A	N/A	Flare Slope RT (%)	N/A
N/A	Flare Traversable LT?	N/A	N/A	Flare Traversable RT?	N/A
N/A	Landing Length (in)	N/A	N/A	DWS Provided?	N/A
N/A	Landing Width (in)	N/A	N/A	DWS Contrast?	N/A
N/A	Landing Slope (%)	N/A	N/A	DWS Length (in)	N/A
N/A	Landing X Slope (%)	N/A	N/A	DWS Full Width?	N/A
N/A	Landing Curb? (Y/N)	N/A	N/A	DWS Offset (in)	N/A
N/A	Shared Landing?	N/A			
N/A	Gutter Ponding?	N/A	N/A	Gutter Slope (%)	N/A
N/A	Gutter Lip Ht (in)	N/A	N/A	Gutter X Slope (%)	N/A
N/A	Painted X Walk1?	No	N/A	Painted X Walk2?	No
	X Walk 1 Direction	To S		X Walk 2 Direction	To E
N/A	X Walk 1 Width (in)	N/A	N/A	X Walk 2 Width (in)	N/A
	X Walk 1 Slope (%)	1.0		X Walk 2 Slope (%)	4.6
	X Walk 1 X Slope (%)	4.9		X Walk 2 X Slope (%)	0.3

N/A	Ramp inside XWalk1?	N/A	N/A	Ramp inside XWalk2?	N/A
	Road Slope (%)	5.4	N/A	Clear Space?	N/A
	Road X Slope (%)	2.9	N/A	Clear Space to XWalk (in)	N/A
N/A	Any Obstructions?	N/A	N/A	Storm Grate/Utility Hazard?	N/A
	Obstruction Type			Storm Grate/Utility Type	
		N/A			N/A
			Yes	Surface Condition? (G/P)	Good

Remove & Replace Curb Ramp With Two New Directional Ramps or Equivalent.

R304.2.2, R304.5.3
