Access Compliance Report

Public Rights-of-Way

(Curb Ramps)

Intersection ID: 2865	Main Street: DOWNFIELD_WOOD_DR	Cross Street: LADY_BANK_DR	Location: S
ADA ID: D73B1C1AA520	Ramp Type: Perp	Initial Pass/Fail: Fail	Overall Compliance: No
Severity Score: 50			
Codes/Mitigation Info/Possible Solution		Field Measurements/Component Compliance

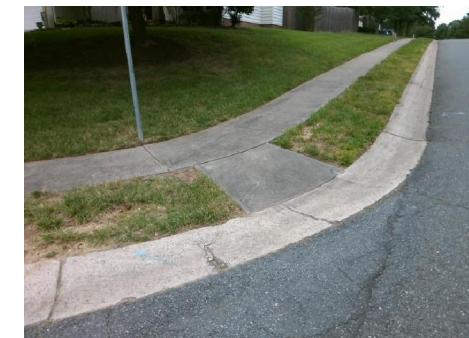
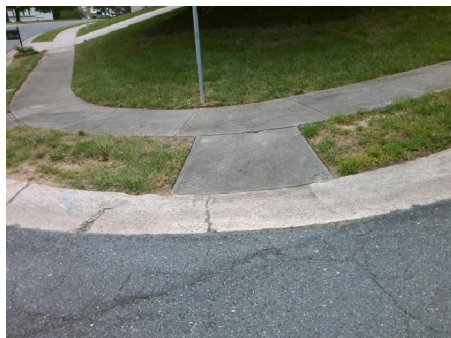
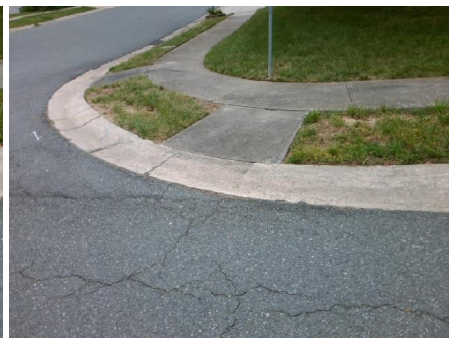
Compliance	Description	Data	Compliance	Description	Data
N/A	Ramp Length (in)	48.0	No	Ramp Slope (%)	13.7
Yes	Ramp Width (in)	48.0	No	Ramp XSlope (%)	9.3
N/A	Flare Type LT	N/A	N/A	Flare Type RT	N/A
N/A	Flare Slope LT (%)	N/A	N/A	Flare Slope RT (%)	N/A
N/A	Flare Traversable LT?	N/A	N/A	Flare Traversable RT?	N/A
N/A	Landing Length (in)	N/A	N/A	DWS Provided?	N/A
N/A	Landing Width (in)	N/A	N/A	DWS Contrast?	N/A
N/A	Landing Slope (%)	N/A	N/A	DWS Length (in)	N/A
N/A	Landing X Slope (%)	N/A	N/A	DWS Full Width?	N/A
N/A	Landing Curb? (Y/N)	N/A	N/A	DWS Offset (in)	N/A
N/A	Shared Landing?	N/A			
N/A	Gutter Ponding?	N/A	N/A	Gutter Slope (%)	N/A
N/A	Gutter Lip Ht (in)	N/A	N/A	Gutter X Slope (%)	N/A
N/A	Painted X Walk1?	No	N/A	Painted X Walk2?	N/A
	X Walk 1 Direction	To NW		X Walk 2 Direction	N/A
N/A	X Walk 1 Width (in)	N/A	N/A	X Walk 2 Width (in)	N/A
	X Walk 1 Slope (%)	1.1		X Walk 2 Slope (%)	N/A
	X Walk 1 X Slope (%)	7.1		X Walk 2 X Slope (%)	N/A

N/A	Ramp inside XWalk1?	N/A	N/A	Ramp inside XWalk2?	N/A
	Road Slope (%)	N/A	N/A	Clear Space?	N/A
	Road X Slope (%)	N/A	N/A	Clear Space to XWalk (in)	N/A
N/A	Any Obstructions?	N/A	N/A	Storm Grate/Utility Hazard?	N/A
	Obstruction Type			Storm Grate/Utility Type	
		N/A			N/A
			Yes	Surface Condition? (G/P)	Good

Possible Solutions:

Remove & Replace Entire Ramp.

R304.2.2, R304.5.3
