Access Compliance Report

Public Rights-of-Way

(Curb Ramps)

Intersection ID: 10113	Main Street: LAKE_AV	Cross Street: RUSH_AV	Location:	E
ADA ID: D73B5BFD389D	Ramp Type: Directional1	Initial Pass/Fail: Fail	Overall Compliance: No	Severity Score: 25
Codes/Mitigation Info/Possible Solution		Field Measurements/Component Compliance

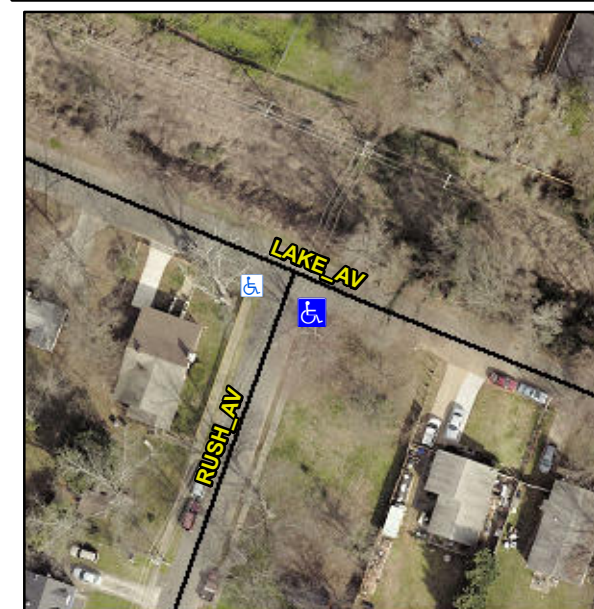
Surveyor Notes:

NO CURB

PROW/ADA:

R304.2.2, R304.5.3

Compliance	Description	Data	Compliance	Description	Data
N/A	Ramp Length (in)	98.0	N/A	Grade Break?	N/A
Yes	Ramp Width (in)	48.0	N/A	Grade Break Slope (%)	0.0
No	Ramp Slope (%)	8.7	N/A	Grade Break XSlope (%)	0.0
No	Ramp XSlope (%)	6.7			
N/A	Flare Type LT	N/A	N/A	Flare Type RT	N/A
N/A	Flare Slope LT (%)	N/A	N/A	Flare Slope RT (%)	0.0
N/A	Flare Traversable LT?	N/A	N/A	Flare Traversable RT?	N/A
N/A	Landing Length (in)	0.0	N/A	DWS Provided?	N/A
N/A	Landing Width (in)	0.0	N/A	DWS Contrast?	N/A
N/A	Landing Slope (%)	0.0	N/A	DWS Length (in)	N/A
N/A	Landing X Slope (%)	0.0	N/A	DWS Full Width?	N/A
N/A	Landing Curb? (Y/N)	N/A	N/A	DWS Offset LT (in)	N/A
N/A	Shared Landing?	N/A	N/A	DWS Offset RT (in)	N/A
N/A	Gutter Ponding?	0.0	N/A	Gutter Slope (%)	N/A
N/A	Gutter Lip Ht (in)	0.0	N/A	Gutter X Slope (%)	N/A
N/A	Painted X Walk1?	No		Road Slope (%)	0.5
	X Walk 1 Direction	To W		Road X Slope (%)	5.5
	X Walk 1 Width (in)	N/A		Clear Space?	N/A

X Walk 1 Slope (%)	0.5	N/A	Clear Space to XWalk (in)	N/A
	X Walk 1 X Slope (%)	5.5	N/A	Storm Grate/Utility Hazard?	N/A
N/A	Ramp inside XWalk1?	N/A		Storm Grate/Utility Type	
N/A	Any Obstructions?	N/A			N/A
	Obstruction Type		Yes	Surface Condition? (G/P)	Good
			N/A	Curb Slope (%)	N/A

Possible Solutions:

Remove & Replace Entire Ramp.
