Access Compliance Report

Public Rights-of-Way

(Curb Ramps)

Intersection ID: 3090	Main Street: AVALON_FOREST_LN	Cross Street: PANTHERSVILLE_DR	Location:	N
ADA ID: D742AC4D4E10	Ramp Type: Perp	Initial Pass/Fail: Fail	Overall Compliance: No	Severity Score: 33.75
Codes/Mitigation Info/Possible Solution		Field Measurements/Component Compliance

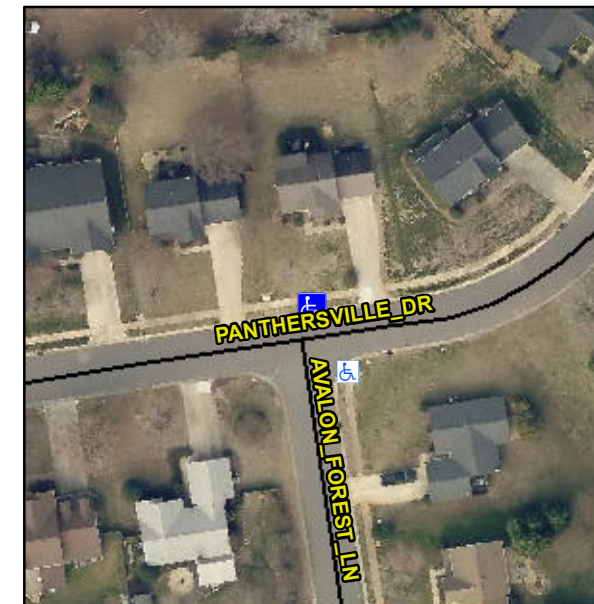
Not Found, R304.5.1, R304.2.2

Compliance	Description	Data	Compliance	Description	Data
N/A	Ramp Length (in)	48.0	No	Ramp Slope (%)	14.4
No	Ramp Width (in)	46.5	Yes	Ramp XSlope (%)	1.1
N/A	Flare Type LT	N/A	N/A	Flare Type RT	N/A
N/A	Flare Slope LT (%)	N/A	N/A	Flare Slope RT (%)	N/A
N/A	Flare Traversable LT?	N/A	N/A	Flare Traversable RT?	N/A
N/A	Landing Length (in)	N/A	N/A	DWS Provided?	N/A
N/A	Landing Width (in)	N/A	N/A	DWS Contrast?	N/A
N/A	Landing Slope (%)	N/A	N/A	DWS Length (in)	N/A
N/A	Landing X Slope (%)	N/A	N/A	DWS Full Width?	N/A
N/A	Landing Curb? (Y/N)	N/A	N/A	DWS Offset (in)	N/A
N/A	Shared Landing?	N/A			
N/A	Gutter Ponding?	N/A	N/A	Gutter Slope (%)	N/A
N/A	Gutter Lip Ht (in)	2.0	N/A	Gutter X Slope (%)	N/A
N/A	Painted X Walk1?	No	N/A	Painted X Walk2?	N/A
	X Walk 1 Direction	To S		X Walk 2 Direction	N/A
N/A	X Walk 1 Width (in)	N/A	N/A	X Walk 2 Width (in)	N/A
	X Walk 1 Slope (%)	5.1		X Walk 2 Slope (%)	N/A
	X Walk 1 X Slope (%)	2.3		X Walk 2 X Slope (%)	N/A

N/A	Ramp inside XWalk1?	N/A	N/A	Ramp inside XWalk2?	N/A
	Road Slope (%)	N/A	N/A	Clear Space?	N/A
	Road X Slope (%)	N/A	N/A	Clear Space to XWalk (in)	N/A
N/A	Any Obstructions?	N/A	N/A	Storm Grate/Utility Hazard?	N/A
	Obstruction Type			Storm Grate/Utility Type	
		N/A			N/A
			Yes	Surface Condition? (G/P)	Good

Remove & Replace Entire Ramp.
