# Access Compliance Report

## Public Rights-of-Way

### (Curb Ramps)

| Intersection ID: 26308 | Main Street: WEDDINGTON_RD | Cross Street: MCKEE_RD | Location: SW |

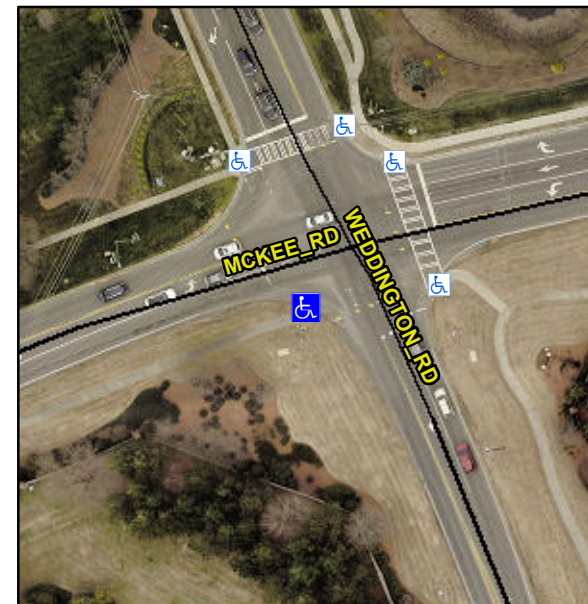
**NO CURB LINE, DAMAGED RT FL**

**R304.2.2-Perp, R304.3.2-Para**

| Compliance | Description | Data | Compliance | Description | Data |
|---|---|---|---|---|---|
| No | Landing Slope (%) | 2.3 | Yes | DWS Length (in) | 24.0 |

**Remove & Replace Landing.**

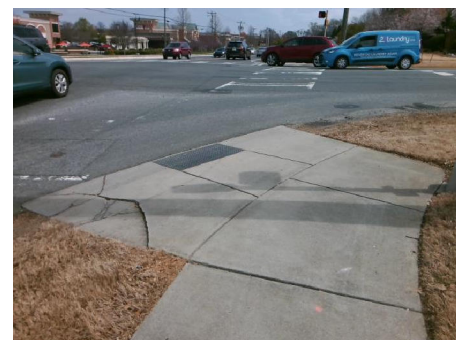
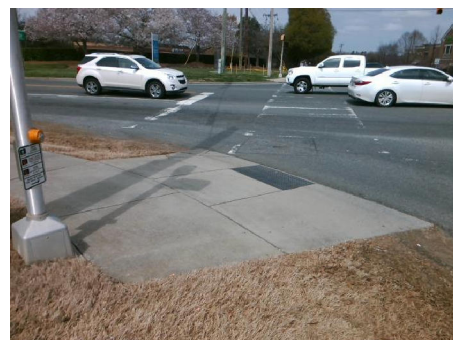
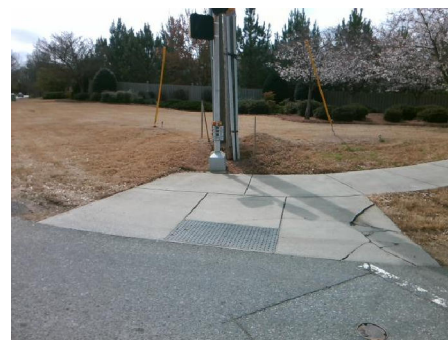
| ADA ID: D7480C2A9823 | Ramp Type: BlendTrans1 | Initial Pass/Fail: Pass | Overall Compliance: No |
