Access Compliance Report

Public Rights-of-Way

(Curb Ramps)

Intersection ID: 23386	Main Street: ALEXANDER_RD	Cross Street: BENNING_WOOD_DR	Location:	N
ADA ID: D750BD351A8A	Ramp Type: Directional1	Initial Pass/Fail: Pass	Overall Compliance: No	Severity Score: 7.5
Codes/Mitigation Info/Possible Solution		Field Measurements/Component Compliance

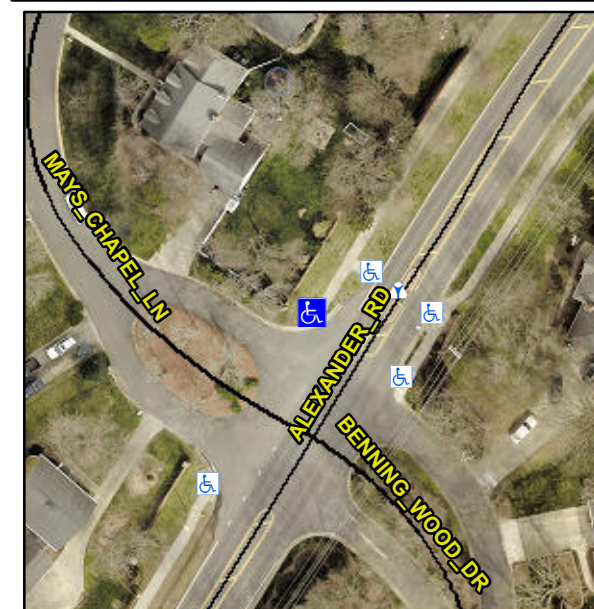
Compliance	Description	Data	Compliance	Description	Data
N/A	Ramp Length (in)	61.0	Yes	Grade Break?	Yes
Yes	Ramp Width (in)	72.0	Yes	Grade Break Slope (%)	2.7
Yes	Ramp Slope (%)	2.4	No	Grade Break XSlope (%)	2.4
Yes	Ramp XSlope (%)	1.1			
N/A	Flare Type LT	N/A	N/A	Flare Type RT	N/A
N/A	Flare Slope LT (%)	N/A	N/A	Flare Slope RT (%)	N/A
N/A	Flare Traversable LT?	N/A	N/A	Flare Traversable RT?	N/A
Yes	Landing Length (in)	53.0	Yes	DWS Provided?	Yes
Yes	Landing Width (in)	72.0	Yes	DWS Contrast?	Yes
Yes	Landing Slope (%)	1.3	Yes	DWS Length (in)	24.5
Yes	Landing X Slope (%)	1.6	No	DWS Full Width?	No
N/A	Landing Curb? (Y/N)	No	Yes	DWS Offset LT (in)	54.5
N/A	Shared Landing?	No	Yes	DWS Offset RT (in)	2.0
Yes	Gutter Ponding?	No	No	Gutter Slope (%)	5.2
Yes	Gutter Lip Ht (in)	0.0	Yes	Gutter X Slope (%)	0.0
N/A	Painted X Walk1?	No		Road Slope (%)	0.6
	X Walk 1 Direction	To SW		Road X Slope (%)	0.7
	X Walk 1 Width (in)	N/A		Clear Space?	Yes

X Walk 1 Slope (%)	0.6	N/A	Clear Space to XWalk (in)	N/A
	X Walk 1 X Slope (%)	0.7	Yes	Storm Grate/Utility Hazard?	No
N/A	Ramp inside XWalk1?	N/A		Storm Grate/Utility Type	
Yes	Any Obstructions?	No			N/A
	Obstruction Type		Yes	Surface Condition? (G/P)	Good
			N/A	Curb Slope (%)	6.1

Possible Solutions:

**Remove & Replace Entire Ramp.
Remove & Replace Gutter.**

R304.5.3, R305.1.4, R304.5.4
