## Access Compliance Report Public Rights-of-Way (Curb Ramps)

Intersection ID: 17345 Main Street: RANDOLPH\_RD Cross Street: AYLESFORD\_RD Location: SE

ADA ID: D756497EF702 Ramp Type: PerpDiag Initial Pass/Fail: Fail Overall Compliance: No Severity Score: 50

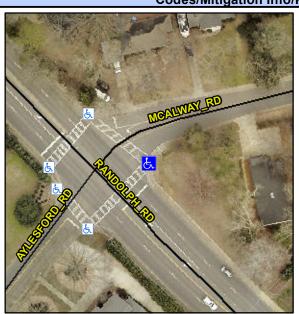
Not Found, R304.2.2, R304.5.3

Field Measurements/Component Compliance					
Compliance Description		Data	Comp	oliance Description	Data
N/A	Ramp Length (in)	50.0	No	Ramp Slope (%)	13.6
Yes	Ramp Width (in)	48.0	No	Ramp XSlope (%)	13.8
N/A	Flare Type LT	N/A	N/A	Flare Type RT	N/A
N/A	Flare Slope LT (%)	N/A	N/A	Flare Slope RT (%)	N/A
N/A	Flare Traversable LT?	N/A	N/A	Flare Traversable RT?	N/A
N/A	Landing Length (in)	N/A	N/A	DWS Provided?	N/A
N/A	Landing Width (in)	N/A	N/A	DWS Contrast?	N/A
N/A	Landing Slope (%)	N/A	N/A	DWS Length (in)	N/A
N/A	Landing X Slope (%)	N/A	N/A	DWS Full Width?	N/A
N/A	Landing Curb? (Y/N)	N/A	N/A	DWS Offset (in)	N/A
N/A	Shared Landing?	N/A			
N/A	Gutter Ponding?	N/A	N/A	Gutter Slope (%)	N/A
N/A	Gutter Lip Ht (in)	N/A	N/A	Gutter X Slope (%)	N/A
N/A	Painted X Walk1?	Yes	N/A	Painted X Walk2?	Yes
	X Walk 1 Direction	To NW		X Walk 2 Direction	To SW
N/A	X Walk 1 Width (in)	112.0	N/A	X Walk 2 Width (in)	101.0
	X Walk 1 Slope (%)	6.6		X Walk 2 Slope (%)	8.7

X Walk 1 X Slope (%)	8.5		X Walk 2 X Slope (%)	7.3
N/A	Ramp inside XWalk1?	Yes	N/A	Ramp inside XWalk2?	Yes
	Road Slope (%)	10.6	N/A	Clear Space?	N/A
	Road X Slope (%)	1.5	N/A	Clear Space to XWalk (in)	N/A
N/A	Any Obstructions?	N/A	N/A	Storm Grate/Utility Hazard?	N/A
	Obstruction Type			Storm Grate/Utility Type	
		N/A			N/A
			Yes	Surface Condition? (G/P)	Good

Remove & Replace Curb Ramp With Two New Directional Ramps or Equivalent.
