Access Compliance Report

Public Rights-of-Way

(Curb Ramps)

Intersection ID: 23574	Main Street: CARMEL_RD	Cross Street: QUAIL_HOLLOW_RD	Location:	N
ADA ID: D7692990FD65	Ramp Type: PerpDiag	Initial Pass/Fail: Fail	Overall Compliance: No	Severity Score: 25

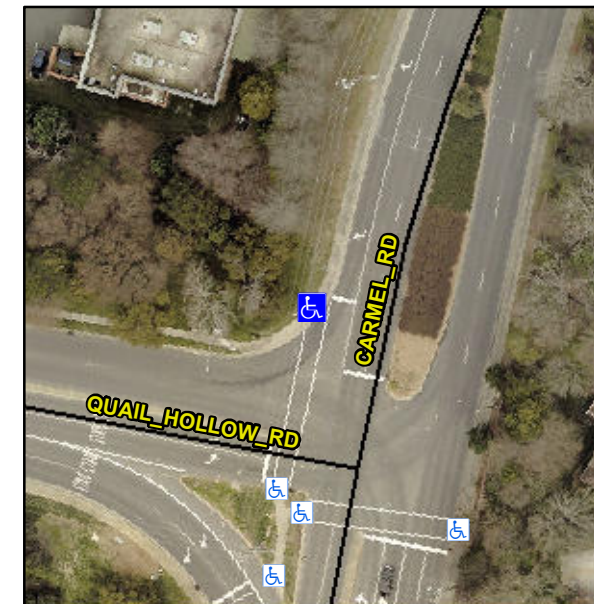
Compliance	Description	Data	Compliance	Description	Data
N/A	Ramp Length (in)	57.0	No	Ramp Slope (%)	12.1
Yes	Ramp Width (in)	48.0	Yes	Ramp XSlope (%)	1.9
N/A	Flare Type LT	N/A	N/A	Flare Type RT	N/A
N/A	Flare Slope LT (%)	N/A	N/A	Flare Slope RT (%)	N/A
N/A	Flare Traversable LT?	N/A	N/A	Flare Traversable RT?	N/A
N/A	Landing Length (in)	N/A	N/A	DWS Provided?	N/A
N/A	Landing Width (in)	N/A	N/A	DWS Contrast?	N/A
N/A	Landing Slope (%)	N/A	N/A	DWS Length (in)	N/A
N/A	Landing X Slope (%)	N/A	N/A	DWS Full Width?	N/A
N/A	Landing Curb? (Y/N)	N/A	N/A	DWS Offset (in)	N/A
N/A	Shared Landing?	N/A			
N/A	Gutter Ponding?	N/A	N/A	Gutter Slope (%)	N/A
N/A	Gutter Lip Ht (in)	N/A	N/A	Gutter X Slope (%)	N/A
N/A	Painted X Walk1?	Yes	N/A	Painted X Walk2?	No
	X Walk 1 Direction	To SW		X Walk 2 Direction	To SE
N/A	X Walk 1 Width (in)	114.0	N/A	X Walk 2 Width (in)	N/A
	X Walk 1 Slope (%)	3.5		X Walk 2 Slope (%)	0.7
	X Walk 1 X Slope (%)	2.1		X Walk 2 X Slope (%)	0.7

N/A	Ramp inside XWalk1?	Yes	N/A	Ramp inside XWalk2?	N/A
	Road Slope (%)	2.1	N/A	Clear Space?	N/A
	Road X Slope (%)	3.5	N/A	Clear Space to XWalk (in)	N/A
N/A	Any Obstructions?	N/A	N/A	Storm Grate/Utility Hazard?	N/A
	Obstruction Type			Storm Grate/Utility Type	
		N/A			N/A
		Yes		Surface Condition? (G/P)	Good

Remove & Replace Curb Ramp With Two New Directional Ramps or Equivalent.

R304.2.2

\$ 3200.00
