# Access Compliance Report

## Public Rights-of-Way (Curb Ramps)

| Intersection ID: 6462 | Main Street: BURGANDY_DR | Cross Street: MINERAL_SPRINGS_RD | Location: | E |
| ADA ID: D7864B9F28F8 | Ramp Type: Directional1 | Initial Pass/Fail: Pass | Overall Compliance: No | Severity Score: 5 |

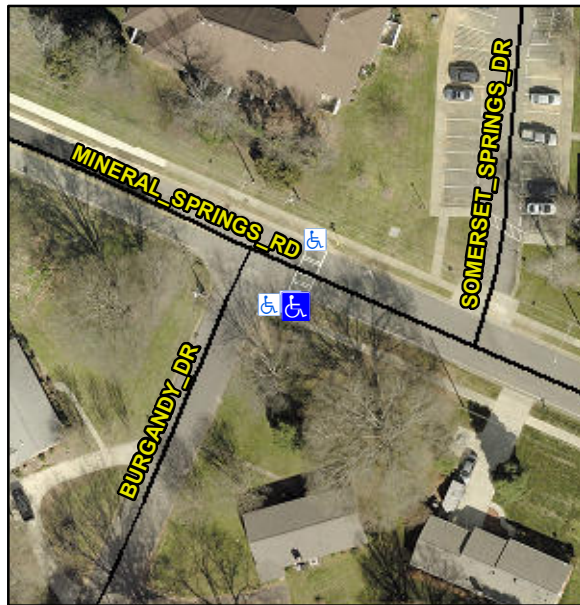
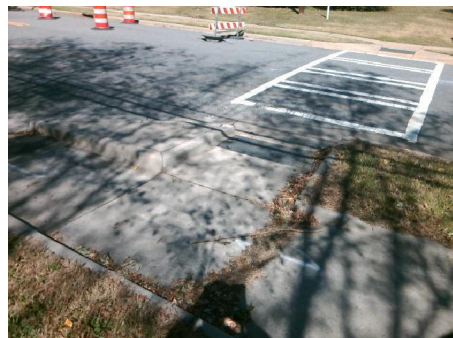
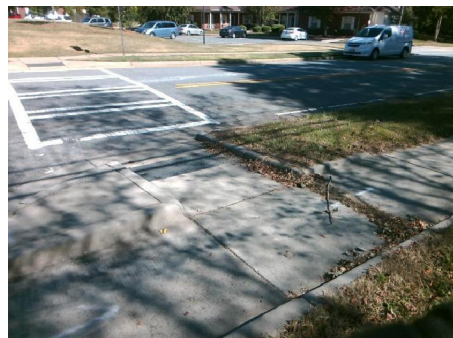
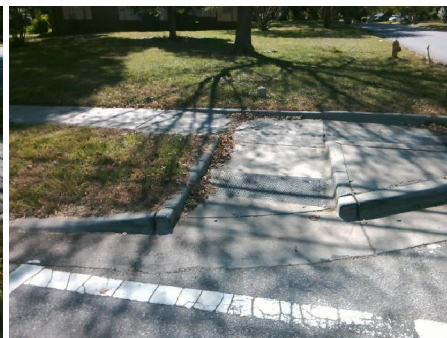
**R304.2.1, R304.2.2-Perp, R304.3.2-Para, R304.2.3**

| Compliance | Description | Data | Compliance | Description | Data |
|---|---|---|---|---|---|
| No | Landing Length (in) | 58.5 | Yes | DWS Provided? | Yes |
| No | Landing Slope (%) | 4.6 | Yes | DWS Length (in) | 24.0 |

**Remove & Replace Entire Ramp.**

Total Cost: \$ 1600.00
