# Access Compliance Report

## Public Rights-of-Way

### (Curb Ramps)

Intersection ID: 14724	Main Street: ALBEMARLE_RD	Cross Street: GUICE_CROSSING_LN	Location: NW
ADA ID: D78955925405	Ramp Type: Perp	Initial Pass/Fail: Fail	Overall Compliance: No
Severity Score: 8.75			
Codes/Mitigation Info/Possible Solution		Field Measurements/Component Compliance

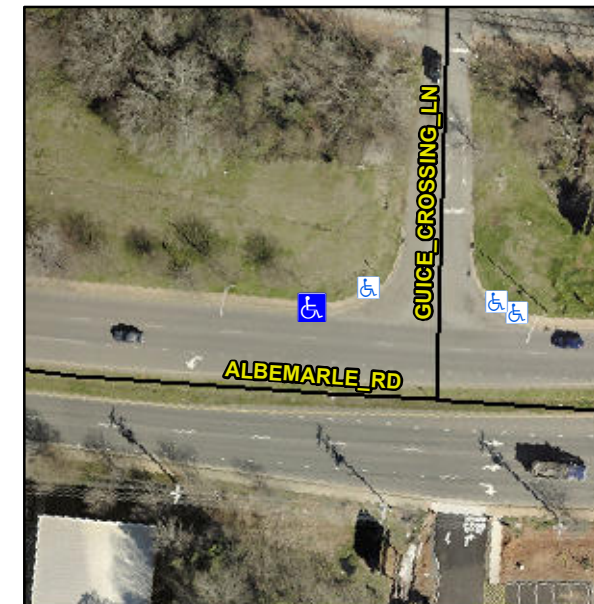
**Not Found, R304.5.1**

Compliance	Description	Data	Compliance	Description	Data
N/A	Ramp Length (in)	60.0	Yes	Ramp Slope (%)	7.1
No	Ramp Width (in)	47.5	Yes	Ramp XSlope (%)	1.6
N/A	Flare Type LT	N/A	N/A	Flare Type RT	N/A
N/A	Flare Slope LT (%)	N/A	N/A	Flare Slope RT (%)	N/A
N/A	Flare Traversable LT?	N/A	N/A	Flare Traversable RT?	N/A
N/A	Landing Length (in)	N/A	N/A	DWS Provided?	N/A
N/A	Landing Width (in)	N/A	N/A	DWS Contrast?	N/A
N/A	Landing Slope (%)	N/A	N/A	DWS Length (in)	N/A
N/A	Landing X Slope (%)	N/A	N/A	DWS Full Width?	N/A
N/A	Landing Curb? (Y/N)	N/A	N/A	DWS Offset (in)	N/A
N/A	Shared Landing?	N/A			
N/A	Gutter Ponding?	N/A	N/A	Gutter Slope (%)	N/A
N/A	Gutter Lip Ht (in)	N/A	N/A	Gutter X Slope (%)	N/A
N/A	Painted X Walk1?	No	N/A	Painted X Walk2?	N/A
	X Walk 1 Direction	To S		X Walk 2 Direction	N/A
N/A	X Walk 1 Width (in)	N/A	N/A	X Walk 2 Width (in)	N/A
	X Walk 1 Slope (%)	1.7		X Walk 2 Slope (%)	N/A
	X Walk 1 X Slope (%)	1.2		X Walk 2 X Slope (%)	N/A

N/A	Ramp inside XWalk1?	N/A	N/A	Ramp inside XWalk2?	N/A
	Road Slope (%)	N/A	N/A	Clear Space?	N/A
	Road X Slope (%)	N/A	N/A	Clear Space to XWalk (in)	N/A
N/A	Any Obstructions?	N/A	N/A	Storm Grate/Utility Hazard?	N/A
	Obstruction Type			Storm Grate/Utility Type	
		N/A			N/A
			Yes	Surface Condition? (G/P)	Good

Possible Solutions:

**Remove & Replace Entire Ramp.**

Total Cost: \$ 1850.00
