Access Compliance Report

Public Rights-of-Way

(Curb Ramps)

Intersection ID: 23470	Main Street: BRANDON_FOREST_DR	Cross Street: STRADBROOK_DR	Location: NW
ADA ID: D78ADA912A9D	Ramp Type: PerpDiag	Initial Pass/Fail: Fail	Overall Compliance: No
Severity Score: 12.5			
Codes/Mitigation Info/Possible Solution		Field Measurements/Component Compliance

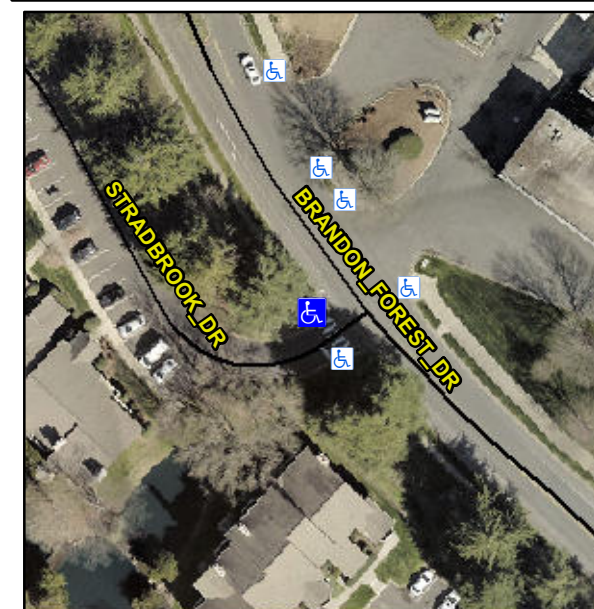
R304.5.3

Compliance	Description	Data	Compliance	Description	Data
N/A	Ramp Length (in)	84.0	Yes	Ramp Slope (%)	6.4
Yes	Ramp Width (in)	48.0	No	Ramp XSlope (%)	5.5
N/A	Flare Type LT	N/A	N/A	Flare Type RT	N/A
N/A	Flare Slope LT (%)	N/A	N/A	Flare Slope RT (%)	N/A
N/A	Flare Traversable LT?	N/A	N/A	Flare Traversable RT?	N/A
N/A	Landing Length (in)	N/A	N/A	DWS Provided?	N/A
N/A	Landing Width (in)	N/A	N/A	DWS Contrast?	N/A
N/A	Landing Slope (%)	N/A	N/A	DWS Length (in)	N/A
N/A	Landing X Slope (%)	N/A	N/A	DWS Full Width?	N/A
N/A	Landing Curb? (Y/N)	N/A	N/A	DWS Offset (in)	N/A
N/A	Shared Landing?	N/A			
N/A	Gutter Ponding?	N/A	N/A	Gutter Slope (%)	N/A
N/A	Gutter Lip Ht (in)	N/A	N/A	Gutter X Slope (%)	N/A
N/A	Painted X Walk1?	Yes	N/A	Painted X Walk2?	No
	X Walk 1 Direction	To SE		X Walk 2 Direction	To E
N/A	X Walk 1 Width (in)	96.0	N/A	X Walk 2 Width (in)	N/A
	X Walk 1 Slope (%)	5.0		X Walk 2 Slope (%)	1.3
	X Walk 1 X Slope (%)	0.8		X Walk 2 X Slope (%)	5.8

N/A	Ramp inside XWalk1?	Yes	N/A	Ramp inside XWalk2?	N/A
	Road Slope (%)	1.6	N/A	Clear Space?	N/A
	Road X Slope (%)	4.2	N/A	Clear Space to XWalk (in)	N/A
N/A	Any Obstructions?	N/A	N/A	Storm Grate/Utility Hazard?	N/A
	Obstruction Type			Storm Grate/Utility Type	
		N/A			N/A
		Yes		Surface Condition? (G/P)	Good

Remove & Replace Curb Ramp With Two New Directional Ramps or Equivalent.

Total Cost: \$ 3200.00
