# Access Compliance Report

## Public Rights-of-Way

### (Curb Ramps)

| Intersection ID: N/A | Main Street: TAMARACK DR | Cross Street: SINGLELEAF LN | Location: E |

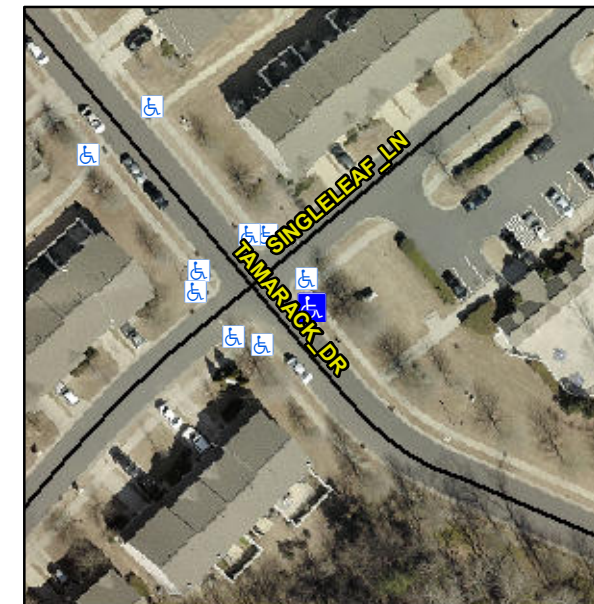
| ADA ID: D78E1CD56451 | Ramp Type: Perp | Initial Pass/Fail: Fail | Overall Compliance: No |
| Severity Score: 12.5 | | | |

**Not Found, R304.2.2**

| Compliance | Description | Data | Compliance | Description | Data |
|---|---|---|---|---|---|
| N/A | Ramp Length (in) | 48.0 | No | Ramp Slope (%) | 8.8 |

**Remove & Replace Entire Ramp.**

Total Cost: \$ 1850.00
