Access Compliance Report

Public Rights-of-Way

(Curb Ramps)

Intersection ID: 26202	Main Street: BALLANTRAE_VILLAGE_DR	Cross Street: SANDPIPER DR	Location: SW
ADA ID: D7930F5D06BB	Ramp Type: PerpDiag	Initial Pass/Fail: Fail	Overall Compliance: No
Codes/Mitigation Info/Possible Solution		Field Measurements/Component Compliance	
Severity Score: 21.25

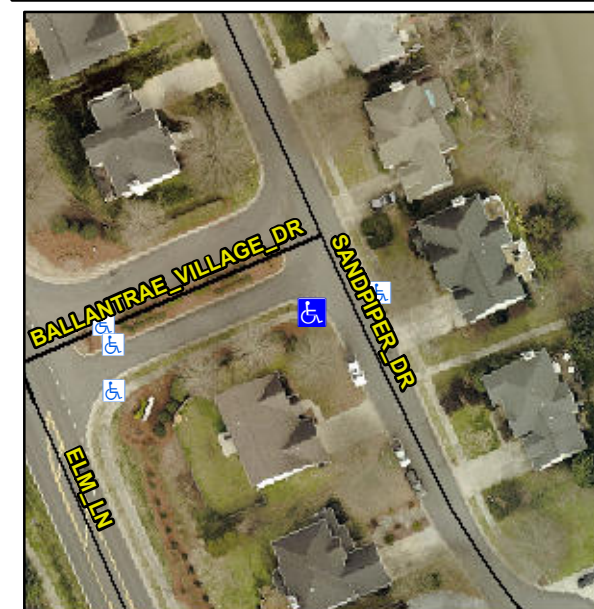
Not Found, R304.5.1, R304.5.3

Compliance	Description	Data	Compliance	Description	Data
N/A	Ramp Length (in)	97.0	Yes	Ramp Slope (%)	7.1
No	Ramp Width (in)	36.0	No	Ramp XSlope (%)	6.6
N/A	Flare Type LT	N/A	N/A	Flare Type RT	N/A
N/A	Flare Slope LT (%)	N/A	N/A	Flare Slope RT (%)	N/A
N/A	Flare Traversable LT?	N/A	N/A	Flare Traversable RT?	N/A
N/A	Landing Length (in)	N/A	N/A	DWS Provided?	N/A
N/A	Landing Width (in)	N/A	N/A	DWS Contrast?	N/A
N/A	Landing Slope (%)	N/A	N/A	DWS Length (in)	N/A
N/A	Landing X Slope (%)	N/A	N/A	DWS Full Width?	N/A
N/A	Landing Curb? (Y/N)	N/A	N/A	DWS Offset (in)	N/A
N/A	Shared Landing?	N/A			
N/A	Gutter Ponding?	N/A	N/A	Gutter Slope (%)	N/A
N/A	Gutter Lip Ht (in)	N/A	N/A	Gutter X Slope (%)	N/A
N/A	Painted X Walk1?	No	N/A	Painted X Walk2?	No
	X Walk 1 Direction	To E		X Walk 2 Direction	To N
N/A	X Walk 1 Width (in)	N/A	N/A	X Walk 2 Width (in)	N/A
	X Walk 1 Slope (%)	1.4		X Walk 2 Slope (%)	0.7
	X Walk 1 X Slope (%)	1.4		X Walk 2 X Slope (%)	2.3

N/A	Ramp inside XWalk1?	N/A	N/A	Ramp inside XWalk2?	N/A
	Road Slope (%)	2.3	N/A	Clear Space?	N/A
	Road X Slope (%)	1.3	N/A	Clear Space to XWalk (in)	N/A
N/A	Any Obstructions?	N/A	N/A	Storm Grate/Utility Hazard?	N/A
	Obstruction Type			Storm Grate/Utility Type	
		N/A			N/A
			Yes	Surface Condition? (G/P)	Good

Possible Solutions:

Remove & Replace Curb Ramp With Two New Directional Ramps or Equivalent.
