Access Compliance Report

Public Rights-of-Way

(Curb Ramps)

Intersection ID: 13716	Main Street: OLD_STEELE_CREEK_RD	Cross Street: HEMPHILL_ST	Location: S
ADA ID: D7932ADEFDF5	Ramp Type: PerpDiag	Initial Pass/Fail: Fail	Overall Compliance: No
Severity Score: 25			
Codes/Mitigation Info/Possible Solution		Field Measurements/Component Compliance

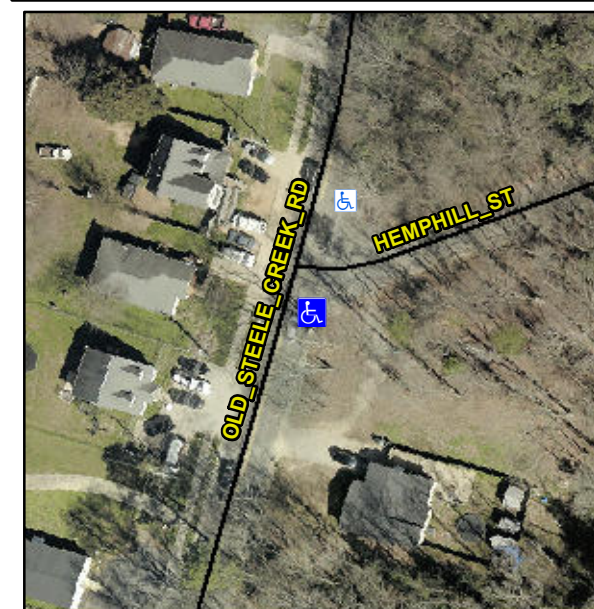
Compliance	Description	Data	Compliance	Description	Data
N/A	Ramp Length (in)	39.0	No	Ramp Slope (%)	15.2
Yes	Ramp Width (in)	48.0	Yes	Ramp XSlope (%)	1.4
N/A	Flare Type LT	N/A	N/A	Flare Type RT	N/A
N/A	Flare Slope LT (%)	N/A	N/A	Flare Slope RT (%)	N/A
N/A	Flare Traversable LT?	N/A	N/A	Flare Traversable RT?	N/A
N/A	Landing Length (in)	N/A	N/A	DWS Provided?	N/A
N/A	Landing Width (in)	N/A	N/A	DWS Contrast?	N/A
N/A	Landing Slope (%)	N/A	N/A	DWS Length (in)	N/A
N/A	Landing X Slope (%)	N/A	N/A	DWS Full Width?	N/A
N/A	Landing Curb? (Y/N)	N/A	N/A	DWS Offset (in)	N/A
N/A	Shared Landing?	N/A			
N/A	Gutter Ponding?	N/A	N/A	Gutter Slope (%)	N/A
N/A	Gutter Lip Ht (in)	N/A	N/A	Gutter X Slope (%)	N/A
N/A	Painted X Walk1?	No	N/A	Painted X Walk2?	No
	X Walk 1 Direction	To N		X Walk 2 Direction	To W
N/A	X Walk 1 Width (in)	N/A	N/A	X Walk 2 Width (in)	N/A
	X Walk 1 Slope (%)	0.5		X Walk 2 Slope (%)	0.5
	X Walk 1 X Slope (%)	0.9		X Walk 2 X Slope (%)	3.2

N/A	Ramp inside XWalk1?	N/A	N/A	Ramp inside XWalk2?	N/A
	Road Slope (%)	1.7	N/A	Clear Space?	N/A
	Road X Slope (%)	0.9	N/A	Clear Space to XWalk (in)	N/A
N/A	Any Obstructions?	N/A	N/A	Storm Grate/Utility Hazard?	N/A
	Obstruction Type			Storm Grate/Utility Type	
		N/A			N/A
		Yes		Surface Condition? (G/P)	Good

Possible Solutions:

Remove & Replace Curb Ramp With Two New Directional Ramps or Equivalent.

Total Cost: \$ 3200.00
