# Access Compliance Report

## Public Rights-of-Way

| Intersection ID: 54014 | Main Street: SPEER_BV | Cross Street: ZILKER_PARK_DR | Location: | N |
| ADA ID: D79462A02FA2 | Ramp Type: Directional1 | Initial Pass/Fail: Pass | Overall Compliance: No | Severity Score: 5 |

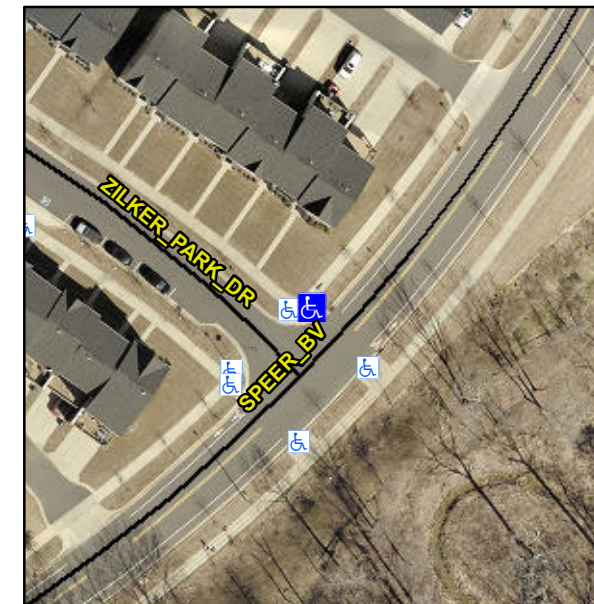
**R305.2, R304.5.4**

| Compliance | Description | Data | Compliance | Description | Data |
|---|---|---|---|---|---|
| N/A | Landing Curb? (Y/N) | No | No | DWS Offset LT (in) | 13.0 |
| Yes | Gutter Ponding? | No | No | Gutter Slope (%) | 6.2 |

**Remove & Replace Detectable Warning System. Remove & Replace Gutter.**

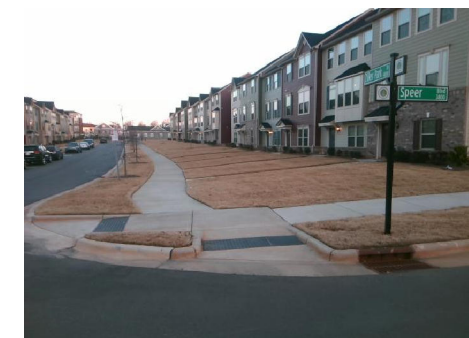
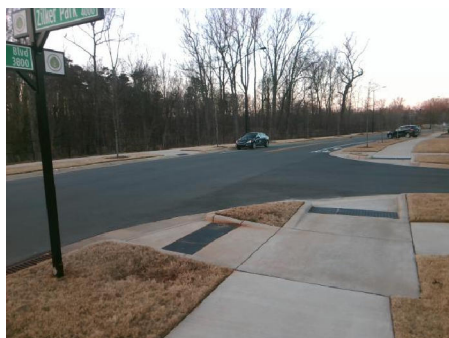
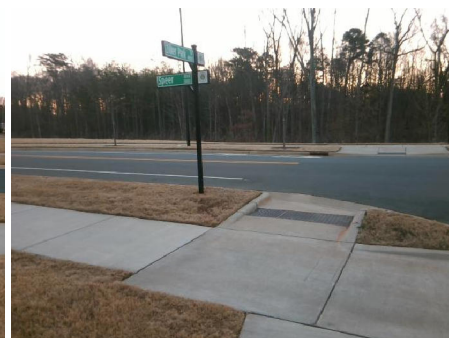
| Compliance | Description | Data | Compliance | Description | Data |
|---|---|---|---|---|---|
| | Obstruction Type | | Yes | Surface Condition? (G/P) | Good |

Possible Solutions:
