Access Compliance Report

Public Rights-of-Way

(Curb Ramps)

Intersection ID: 7290	Main Street: AUTEN_AV	Cross Street: STATESVILLE_RD	Location: SW
ADA ID: D79A8308099B	Ramp Type: Perp	Initial Pass/Fail: Fail	Overall Compliance: No
			Severity Score: 23.75

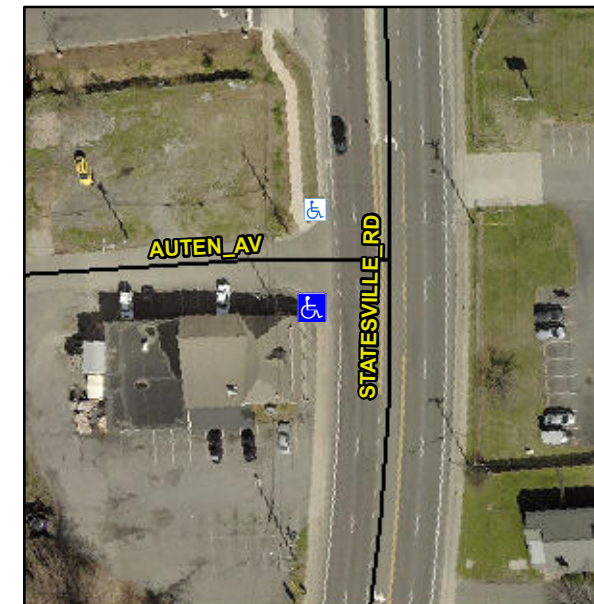
Not Found, R304.5.1, R302.7

Compliance	Description	Data	Compliance	Description	Data
N/A	Ramp Length (in)	61.0	Yes	Ramp Slope (%)	6.1
No	Ramp Width (in)	36.0	Yes	Ramp XSlope (%)	0.3
N/A	Flare Type LT	N/A	N/A	Flare Type RT	N/A
N/A	Flare Slope LT (%)	N/A	N/A	Flare Slope RT (%)	N/A
N/A	Flare Traversable LT?	N/A	N/A	Flare Traversable RT?	N/A
N/A	Landing Length (in)	N/A	N/A	DWS Provided?	N/A
N/A	Landing Width (in)	N/A	N/A	DWS Contrast?	N/A
N/A	Landing Slope (%)	N/A	N/A	DWS Length (in)	N/A
N/A	Landing X Slope (%)	N/A	N/A	DWS Full Width?	N/A
N/A	Landing Curb? (Y/N)	N/A	N/A	DWS Offset (in)	N/A
N/A	Shared Landing?	N/A			
N/A	Gutter Ponding?	Yes	N/A	Gutter Slope (%)	N/A
N/A	Gutter Lip Ht (in)	1.0	N/A	Gutter X Slope (%)	N/A
N/A	Painted X Walk1?	No	N/A	Painted X Walk2?	N/A
	X Walk 1 Direction	To N		X Walk 2 Direction	N/A
N/A	X Walk 1 Width (in)	N/A	N/A	X Walk 2 Width (in)	N/A
	X Walk 1 Slope (%)	0.2		X Walk 2 Slope (%)	N/A
	X Walk 1 X Slope (%)	4.3		X Walk 2 X Slope (%)	N/A

N/A	Ramp inside XWalk1?	N/A	N/A	Ramp inside XWalk2?	N/A
	Road Slope (%)	N/A	N/A	Clear Space?	N/A
	Road X Slope (%)	N/A	N/A	Clear Space to XWalk (in)	N/A
N/A	Any Obstructions?	N/A	N/A	Storm Grate/Utility Hazard?	N/A
	Obstruction Type			Storm Grate/Utility Type	
		N/A			N/A
		No		Surface Condition? (G/P)	Poor

Remove & Replace Entire Ramp.
