# Access Compliance Report

## Public Rights-of-Way

### (Curb Ramps)

Intersection ID: 29414	Main Street: LINDA_LAKE_DR	Cross Street: POSSUM_TROT_LN	Location: S
ADA ID: D7A3996D0A51	Ramp Type: BlendTrans1	Initial Pass/Fail: Fail	Overall Compliance: No
		Severity Score: 8.75

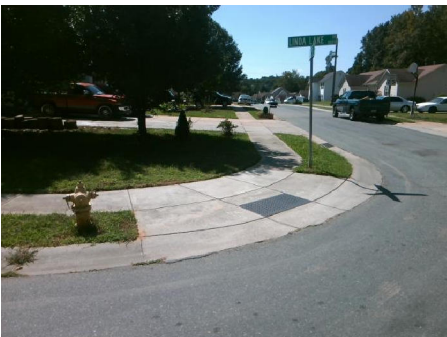
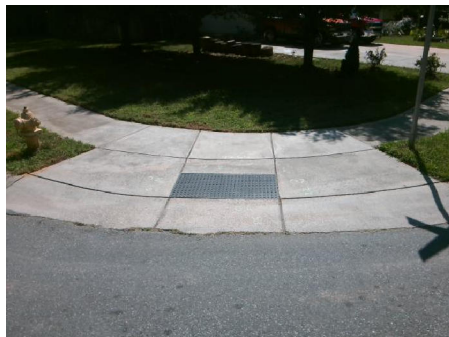
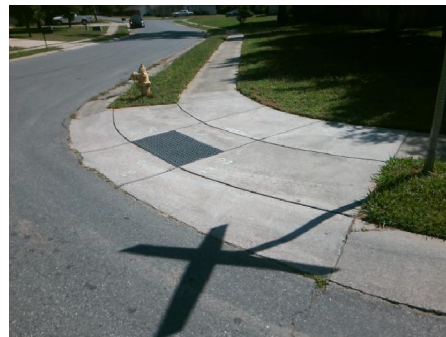
**Not Found, R304.5.1**

Compliance	Description	Data	Compliance	Description	Data
N/A	Ramp Length (in)	44.0	Yes	BlendTrans Slope (%)	3.1
No	Ramp Width (in)	47.5	Yes	BlendTrans XSlope (%)	1.5
N/A	Flare Type LT	N/A	N/A	Flare Type RT	N/A
N/A	Flare Slope LT (%)	N/A	N/A	Flare Slope RT (%)	N/A
N/A	Flare Traversable LT?	N/A	N/A	Flare Traversable RT?	N/A
N/A	Landing Length (in)	N/A	N/A	DWS Provided?	N/A
N/A	Landing Width (in)	N/A	N/A	DWS Contrast?	N/A
N/A	Landing Slope (%)	N/A	N/A	DWS Length (in)	N/A
N/A	Landing X Slope (%)	N/A	N/A	DWS Full Width?	N/A
N/A	Landing Curb? (Y/N)	N/A	N/A	DWS Offset (in)	N/A
N/A	Shared Landing?	N/A			
N/A	Gutter Ponding?	N/A	N/A	Gutter Slope (%)	N/A
N/A	Gutter Lip Ht (in)	N/A	N/A	Gutter X Slope (%)	N/A
N/A	Painted X Walk1?	No	N/A	Painted X Walk2?	No
	X Walk 1 Direction	To NE		X Walk 2 Direction	To NW
	X Walk 1 Width (in)	N/A		X Walk 2 Width (in)	N/A
	X Walk 1 Slope (%)	1.5		X Walk 2 Slope (%)	2.2
	X Walk 1 X Slope (%)	0.2		X Walk 2 X Slope (%)	0.7

N/A	Ramp inside XWalk1?	N/A	N/A	Ramp inside XWalk2?	N/A
	Road Slope (%)	0.6		Clear Space?	N/A
	Road X Slope (%)	5.1	N/A	Clear Space to XWalk (in)	N/A
N/A	Any Obstructions?	N/A	N/A	Storm Grate/Utility Hazard?	N/A
	Obstruction Type			Storm Grate/Utility Type	
		N/A			N/A
			Yes	Surface Condition? (G/P)	Good
			No	Curb Slope (%)	7.4

**Remove & Replace Curb Ramp With Two New Directional Ramps or Equivalent.**
