Access Compliance Report

Public Rights-of-Way

(Curb Ramps)

Intersection ID: 22230	Main Street: N_SARDIS_VIEW_LN	Cross Street: SARDIS_RD	Location: N
ADA ID: D7A845248C53	Ramp Type: PerpDiag	Initial Pass/Fail: Fail	Overall Compliance: No
Severity Score: 8.75			
Codes/Mitigation Info/Possible Solution		Field Measurements/Component Compliance

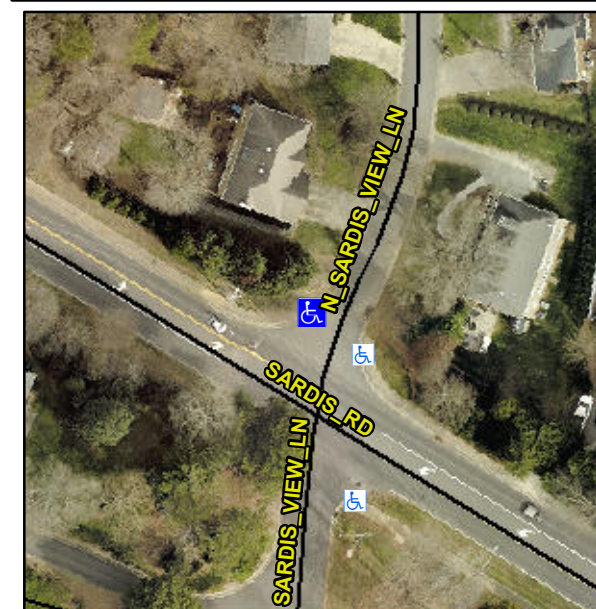
Compliance	Description	Data	Compliance	Description	Data
N/A	Ramp Length (in)	60.0	Yes	Ramp Slope (%)	8.3
No	Ramp Width (in)	42.0	Yes	Ramp XSlope (%)	2.0
N/A	Flare Type LT	N/A	N/A	Flare Type RT	N/A
N/A	Flare Slope LT (%)	N/A	N/A	Flare Slope RT (%)	N/A
N/A	Flare Traversable LT?	N/A	N/A	Flare Traversable RT?	N/A
N/A	Landing Length (in)	N/A	N/A	DWS Provided?	N/A
N/A	Landing Width (in)	N/A	N/A	DWS Contrast?	N/A
N/A	Landing Slope (%)	N/A	N/A	DWS Length (in)	N/A
N/A	Landing X Slope (%)	N/A	N/A	DWS Full Width?	N/A
N/A	Landing Curb? (Y/N)	N/A	N/A	DWS Offset (in)	N/A
N/A	Shared Landing?	N/A			
N/A	Gutter Ponding?	N/A	N/A	Gutter Slope (%)	N/A
N/A	Gutter Lip Ht (in)	N/A	N/A	Gutter X Slope (%)	N/A
N/A	Painted X Walk1?	No	N/A	Painted X Walk2?	No
	X Walk 1 Direction	To SW		X Walk 2 Direction	To SE
N/A	X Walk 1 Width (in)	N/A	N/A	X Walk 2 Width (in)	N/A
	X Walk 1 Slope (%)	0.9		X Walk 2 Slope (%)	4.4
	X Walk 1 X Slope (%)	5.6		X Walk 2 X Slope (%)	2.8

N/A	Ramp inside XWalk1?	N/A	N/A	Ramp inside XWalk2?	N/A
	Road Slope (%)	2.8	N/A	Clear Space?	N/A
	Road X Slope (%)	5.8	N/A	Clear Space to XWalk (in)	N/A
N/A	Any Obstructions?	N/A	N/A	Storm Grate/Utility Hazard?	N/A
	Obstruction Type			Storm Grate/Utility Type	
		N/A			N/A
		Yes		Surface Condition? (G/P)	Good

Possible Solutions:

Remove & Replace Curb Ramp With Two New Directional Ramps or Equivalent.

R304.5.1

\$ 3200.00

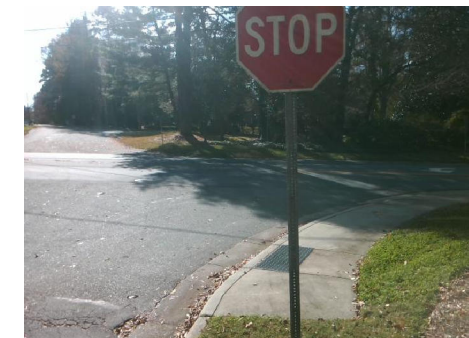
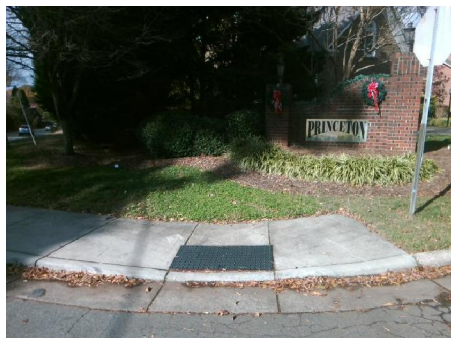
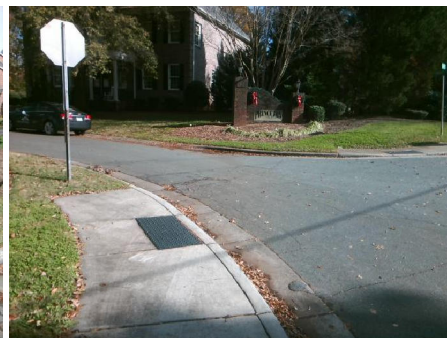
Street 1 Name **SARDIS RD**
 Stop Condition-Street 2 **None**
 Street 2 Name **N SARDIS VIEW LN**
 Stop Condition-Street 1 **StopSign**
