# Access Compliance Report

## Public Rights-of-Way

### (Curb Ramps)

| Intersection ID: 2789 | Main Street: MARSHBANK_LN | Cross Street: RIDGEFIELD_DR | Location: NW |

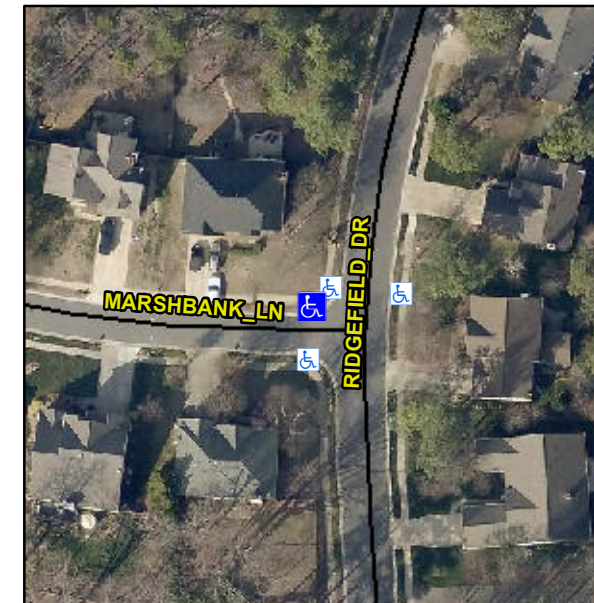
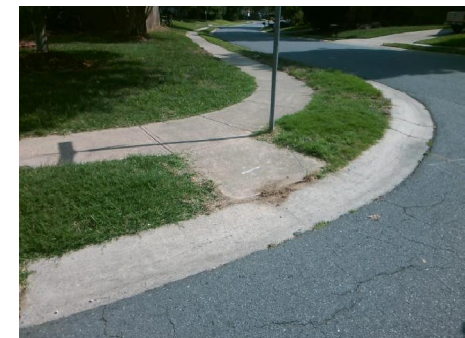
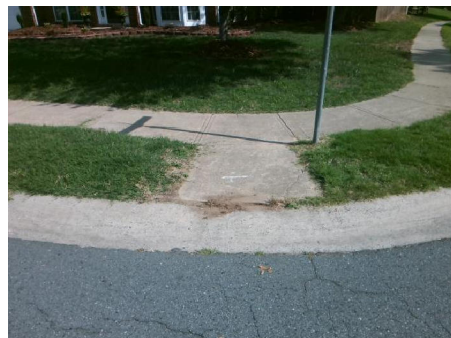
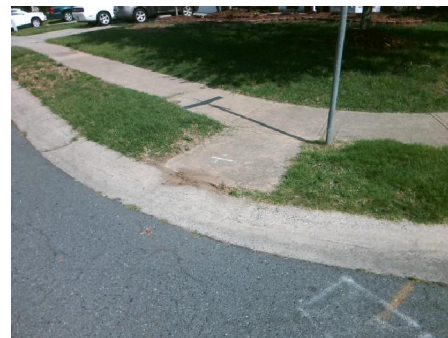
| ADA ID: D7AD6B2F322D | Ramp Type: BlendTrans1 | Initial Pass/Fail: Fail | Overall Compliance: No |
| | | Severity Score: 8.75 | |

| Compliance | Description | Data | Compliance | Description | Data |
|---|---|---|---|---|---|
| No | Ramp Width (in) | 38.0 | Yes | BlendTrans XSlope (%) | 0.3 |

**Remove & Replace Curb Ramp With Two New Directional Ramps or Equivalent.**

**R304.5.1**
