Access Compliance Report

Public Rights-of-Way

(Curb Ramps)

Intersection ID: 12344	Main Street: REMOUNT_RD	Cross Street: GREENLAND_AV	Location: NE
ADA ID: D7B18B643EF2	Ramp Type: Perp	Initial Pass/Fail: Fail	Overall Compliance: No
		Severity Score: 8.75

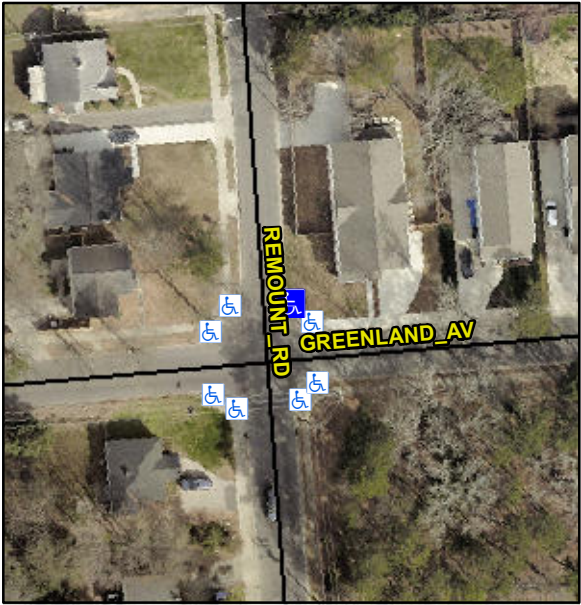
Possible Solutions:		Compliance	Description	Data
	Remove & Replace Entire Ramp.		Yes	Ramp Length (in)	61.0
			No	Ramp Width (in)	47.5
			N/A	Flare Type LT	N/A
			N/A	Flare Slope LT (%)	N/A
			N/A	Flare Traversable LT?	N/A
			N/A	Landing Length (in)	N/A
			N/A	Landing Width (in)	N/A
			N/A	Landing Slope (%)	N/A
			N/A	Landing X Slope (%)	N/A
<p>Surveyor Notes:</p> <p>N/A</p>			N/A	Landing Curb? (Y/N)	N/A
			N/A	Shared Landing?	N/A
			N/A	Gutter Ponding?	N/A
			N/A	Gutter Lip Ht (in)	N/A
			N/A	Painted X Walk1?	No
			N/A	X Walk 1 Direction	To W
			N/A	X Walk 1 Width (in)	N/A
			N/A	X Walk 1 Slope (%)	2.1
			N/A	X Walk 1 X Slope (%)	0.0
			N/A	Ramp inside XWalk1?	N/A
<p>PROW/ADA:</p> <p>Not Found, R304.5.1</p>			N/A	Road Slope (%)	N/A
			N/A	Road X Slope (%)	N/A
			N/A	Any Obstructions?	N/A
			N/A	Obstruction Type	
			N/A		
			N/A
