Access Compliance Report

Public Rights-of-Way

(Curb Ramps)

Intersection ID: 30473	Main Street: BEDDINGFIELD_DR	Cross Street: PLANTERS_ROW_DR	Location: SE
ADA ID: D7B39B05744D	Ramp Type: PerpDiag	Initial Pass/Fail: Fail	Overall Compliance: No
Severity Score: 47.5			
Codes/Mitigation Info/Possible Solution		Field Measurements/Component Compliance

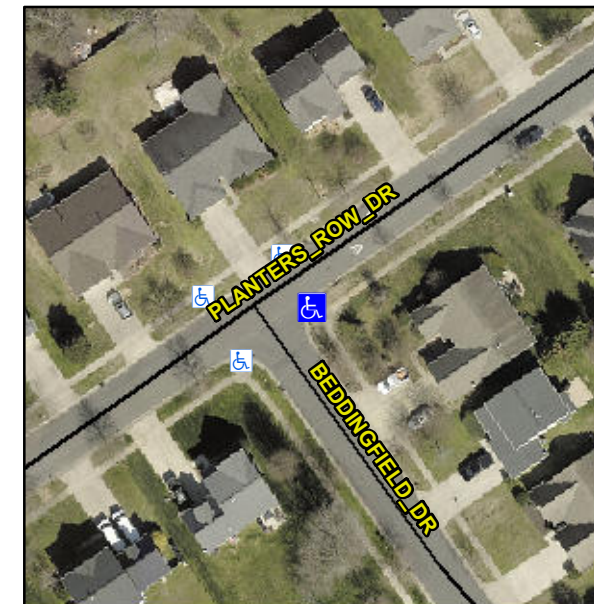
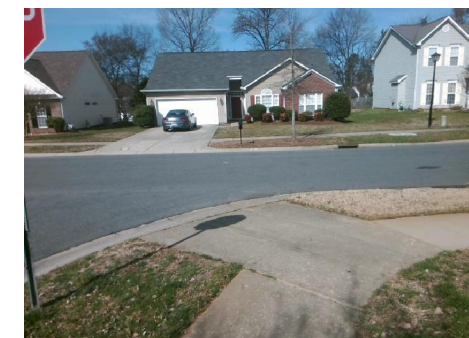
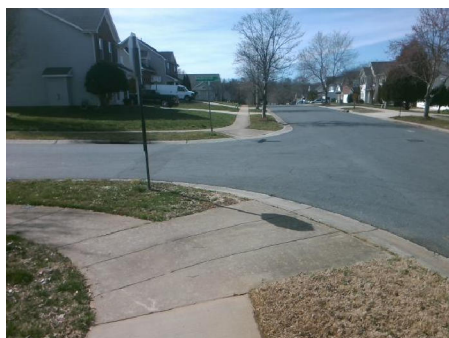
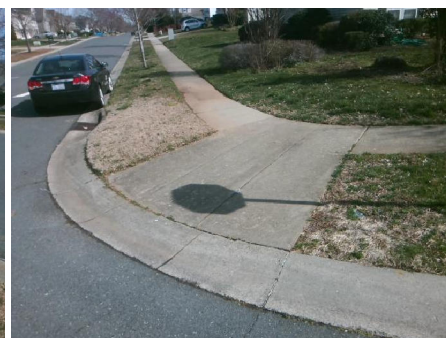
Not Found, R304.5.1, R304.2.2

Compliance	Description	Data	Compliance	Description	Data
N/A	Ramp Length (in)	92.0	No	Ramp Slope (%)	9.6
No	Ramp Width (in)	31.0	Yes	Ramp XSlope (%)	1.1
N/A	Flare Type LT	N/A	N/A	Flare Type RT	N/A
N/A	Flare Slope LT (%)	N/A	N/A	Flare Slope RT (%)	N/A
N/A	Flare Traversable LT?	N/A	N/A	Flare Traversable RT?	N/A
N/A	Landing Length (in)	N/A	N/A	DWS Provided?	N/A
N/A	Landing Width (in)	N/A	N/A	DWS Contrast?	N/A
N/A	Landing Slope (%)	N/A	N/A	DWS Length (in)	N/A
N/A	Landing X Slope (%)	N/A	N/A	DWS Full Width?	N/A
N/A	Landing Curb? (Y/N)	N/A	N/A	DWS Offset (in)	N/A
N/A	Shared Landing?	N/A			
N/A	Gutter Ponding?	N/A	N/A	Gutter Slope (%)	N/A
N/A	Gutter Lip Ht (in)	N/A	N/A	Gutter X Slope (%)	N/A
N/A	Painted X Walk1?	No	N/A	Painted X Walk2?	No
	X Walk 1 Direction	To NW		X Walk 2 Direction	To SW
N/A	X Walk 1 Width (in)	N/A	N/A	X Walk 2 Width (in)	N/A
	X Walk 1 Slope (%)	1.9		X Walk 2 Slope (%)	1.9
	X Walk 1 X Slope (%)	1.7		X Walk 2 X Slope (%)	0.1

N/A	Ramp inside XWalk1?	N/A	N/A	Ramp inside XWalk2?	N/A
	Road Slope (%)	1.3	N/A	Clear Space?	N/A
	Road X Slope (%)	1.9	N/A	Clear Space to XWalk (in)	N/A
N/A	Any Obstructions?	N/A	N/A	Storm Grate/Utility Hazard?	N/A
	Obstruction Type			Storm Grate/Utility Type	
		N/A			N/A
			Yes	Surface Condition? (G/P)	Good

Remove & Replace Curb Ramp With Two New Directional Ramps or Equivalent.
