Access Compliance Report

Public Rights-of-Way

(Curb Ramps)

| Intersection ID: 28184 | Main Street: BLAKENEY PROFESSIONAL DR | Cross Street: ARDREY KELL RD | Location: SE |

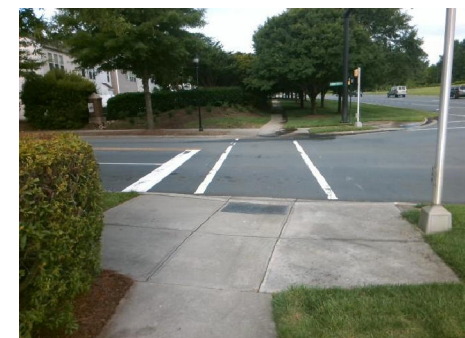
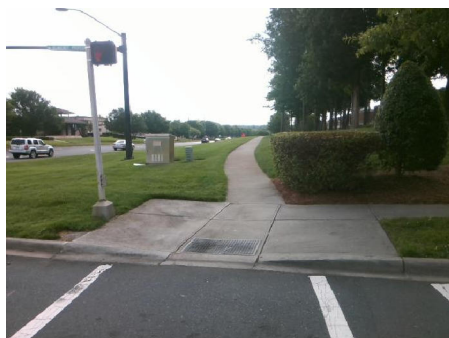
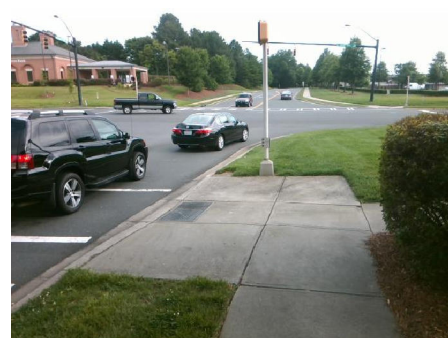
| Compliance | Description | Data | Compliance | Description | Data |
|---|---|---|---|---|---|
| Yes | Ramp Width (in) | 49.0 | No | BlendTrans XSlope (%) | 5.1 |
| | | | Yes | Surface Condition? (G/P) | Good |

Remove & Replace Curb Ramp With Two New Directional Ramps or Equivalent.
