# Access Compliance Report

## Public Rights-of-Way

### (Curb Ramps)

Intersection ID: 42957	Main Street: PHEASANT_GLEN_RD	Cross Street: SPARROW_SPRINGS_LN	Location: NE
ADA ID: D7C98E454376	Ramp Type: PerpDiag	Initial Pass/Fail: Pass	Overall Compliance: No
			Severity Score: 10.25

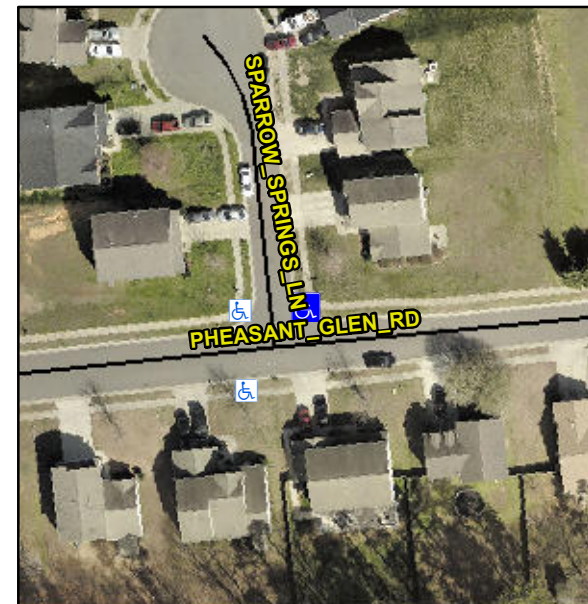
Compliance	Description	Data	Compliance	Description	Data
N/A	Ramp Length (in)	48.5	Yes	Ramp Slope (%)	6.0
Yes	Ramp Width (in)	48.0	No	Ramp XSlope (%)	2.6
N/A	Flare Type LT	Sloped	N/A	Flare Type RT	N/A
N/A	Flare Slope LT (%)	2.7	Yes	Flare Slope RT (%)	3.8
N/A	Flare Traversable LT?	Yes	N/A	Flare Traversable RT?	Yes
No	Landing Length (in)	45.5	No	DWS Provided?	No
Yes	Landing Width (in)	59.0	N/A	DWS Contrast?	No
Yes	Landing Slope (%)	1.9	N/A	DWS Length (in)	N/A
Yes	Landing X Slope (%)	0.8	N/A	DWS Full Width?	No
N/A	Landing Curb? (Y/N)	No	N/A	DWS Offset (in)	N/A
N/A	Shared Landing?	No			
Yes	Gutter Ponding?	No	Yes	Gutter Slope (%)	0.7
Yes	Gutter Lip Ht (in)	0.0	No	Gutter X Slope (%)	3.1
N/A	Painted X Walk1?	No	N/A	Painted X Walk2?	No
	X Walk 1 Direction	To W		X Walk 2 Direction	To S
N/A	X Walk 1 Width (in)	N/A	N/A	X Walk 2 Width (in)	N/A
	X Walk 1 Slope (%)	3.3		X Walk 2 Slope (%)	3.0
	X Walk 1 X Slope (%)	3.9		X Walk 2 X Slope (%)	3.5

N/A	Ramp inside XWalk1?	N/A	N/A	Ramp inside XWalk2?	N/A
	Road Slope (%)	0.5	N/A	Clear Space?	Yes
	Road X Slope (%)	5.3	N/A	Clear Space to XWalk (in)	N/A
Yes	Any Obstructions?	No	Yes	Storm Grate/Utility Hazard?	No
	Obstruction Type			Storm Grate/Utility Type	
		N/A			N/A
			Yes	Surface Condition? (G/P)	Good

**Remove & Replace Curb Ramp With Two New Directional Ramps or Equivalent. Remove & Replace Gutter.**

**R304.5.3, R304.2.1, R305**
