Access Compliance Report

Public Rights-of-Way (Curb Ramps)

Intersection ID: 25688	Main Street: PLANTERS RIDGE RD	Cross Street: PROVIDENCE TRAIL LN	Location:	N
ADA ID: D7CC246725E1	Ramp Type: Perp	Initial Pass/Fail: Fail	Overall Compliance: No	Severity Score: 47.5

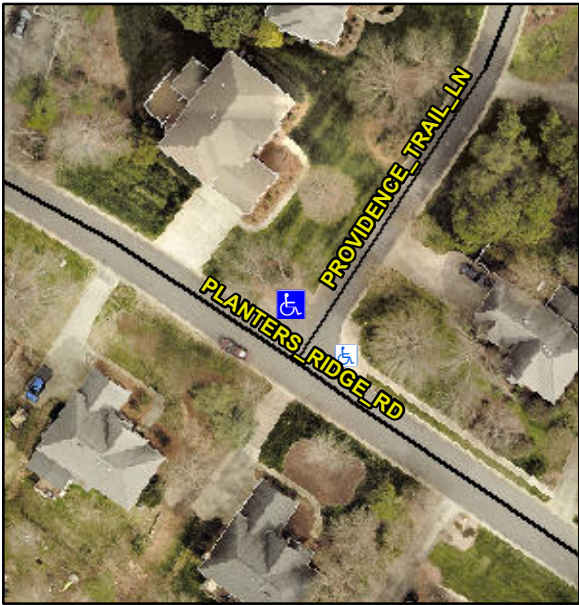
Possible Solutions:		Compliance	Description	Data	Compliance	Description	Data
	Remove & Replace Entire Ramp.		N/A	Ramp Length (in)	95.0	No	Ramp Slope (%)	9.8
			No	Ramp Width (in)	24.0	Yes	Ramp XSlope (%)	1.4
			N/A	Flare Type LT	N/A	N/A	Flare Type RT	N/A
			N/A	Flare Slope LT (%)	N/A	N/A	Flare Slope RT (%)	N/A
			N/A	Flare Traversable LT?	N/A	N/A	Flare Traversable RT?	N/A
			N/A	Landing Length (in)	N/A	N/A	DWS Provided?	N/A
			N/A	Landing Width (in)	N/A	N/A	DWS Contrast?	N/A
			N/A	Landing Slope (%)	N/A	N/A	DWS Length (in)	N/A
			N/A	Landing X Slope (%)	N/A	N/A	DWS Full Width?	N/A
Surveyor Notes:		N/A	N/A	Landing Curb? (Y/N)	N/A	N/A	DWS Offset (in)	N/A
PROW/ADA:		Not Found, R304.5.1, R304.2.2	N/A	Shared Landing?	N/A	N/A	Gutter Slope (%)	N/A
			N/A	Gutter Ponding?	N/A	N/A	Gutter X Slope (%)	N/A
			N/A	Gutter Lip Ht (in)	N/A	N/A	Painted X Walk2?	N/A

N/A	Painted X Walk1?	No	N/A	X Walk 2 Direction	N/A
				X Walk 1 Direction	To SE		X Walk 2 Width (in)	N/A
			N/A	X Walk 1 Width (in)	N/A	N/A	X Walk 2 Slope (%)	N/A
				X Walk 1 Slope (%)	3.1		X Walk 2 X Slope (%)	N/A
				X Walk 1 X Slope (%)	3.6		Ramp inside XWalk2?	N/A
			N/A	Ramp inside XWalk1?	N/A	N/A	Clear Space?	N/A
				Road Slope (%)	N/A	N/A	Clear Space to XWalk (in)	N/A
				Road X Slope (%)	N/A	N/A	Storm Grate/Utility Hazard?	N/A
			N/A	Any Obstructions?	N/A	N/A	Storm Grate/Utility Type	
				Obstruction Type				N/A
						N/A		
						Yes	Surface Condition? (G/P)	Good
