Access Compliance Report

Public Rights-of-Way

(Curb Ramps)

Intersection ID: 51609	Main Street: MASTERTON_RD	Cross Street: MOSSBURN_RD	Location: NW
ADA ID: D7DA59DFA7A3	Ramp Type: Perp	Initial Pass/Fail: Fail	Overall Compliance: No
		Severity Score: 37.5

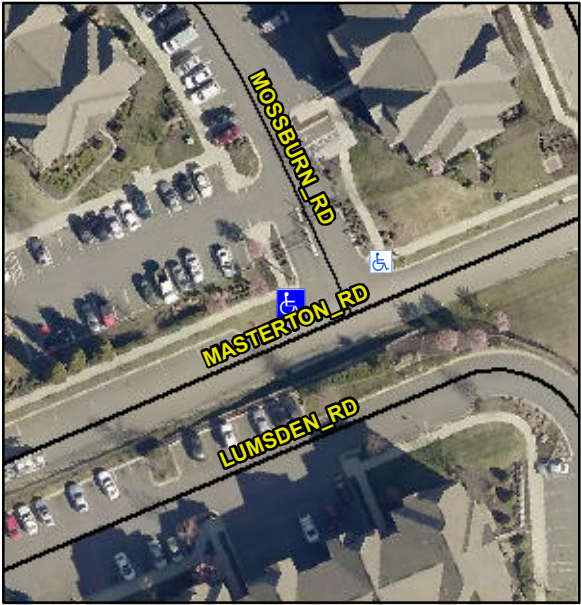
Possible Solutions:		Compliance	Description	Data
	Remove & Replace Entire Ramp.		N/A	Ramp Length (in)	31.0
			Yes	Ramp Width (in)	50.5
			N/A	Flare Type LT	N/A
			N/A	Flare Slope LT (%)	N/A
			N/A	Flare Traversable LT?	N/A
			N/A	Landing Length (in)	N/A
			N/A	Landing Width (in)	N/A
			N/A	Landing Slope (%)	N/A
			N/A	Landing X Slope (%)	N/A
<p>Surveyor Notes:</p> <p>N/A</p> <p>PROW/ADA:</p> <p>R304.2.2, R304.5.3</p>			N/A	Flare Type RT	N/A
			N/A	Flare Slope RT (%)	N/A
			N/A	Flare Traversable RT?	N/A
			N/A	DWS Provided?	N/A
			N/A	DWS Contrast?	N/A
			N/A	DWS Length (in)	N/A
			N/A	DWS Full Width?	N/A
			N/A	DWS Offset (in)	N/A
			N/A	Gutter Ponding?	N/A
			N/A	Gutter Lip Ht (in)	N/A
			N/A	Painted X Walk1?	No
				X Walk 1 Direction	To E
			N/A	X Walk 1 Width (in)	N/A
				X Walk 1 Slope (%)	10.0
				X Walk 1 X Slope (%)	0.4

N/A	Ramp inside XWalk1?	N/A
				Road Slope (%)	N/A
				Road X Slope (%)	N/A
			N/A	Any Obstructions?	N/A
				Obstruction Type	
Total Cost:			\$	1850.00	
			N/A		N/A
			Yes	Surface Condition? (G/P)	Good
