Access Compliance Report

Public Rights-of-Way

(Curb Ramps)

Intersection ID: 16745	Main Street: MARYLAND_AV	Cross Street: PRINCETON_AV	Location: SW
ADA ID: D7DB5C513A08	Ramp Type: PerpDiag	Initial Pass/Fail: Fail	Overall Compliance: No
Severity Score: 33.75			
Codes/Mitigation Info/Possible Solution		Field Measurements/Component Compliance

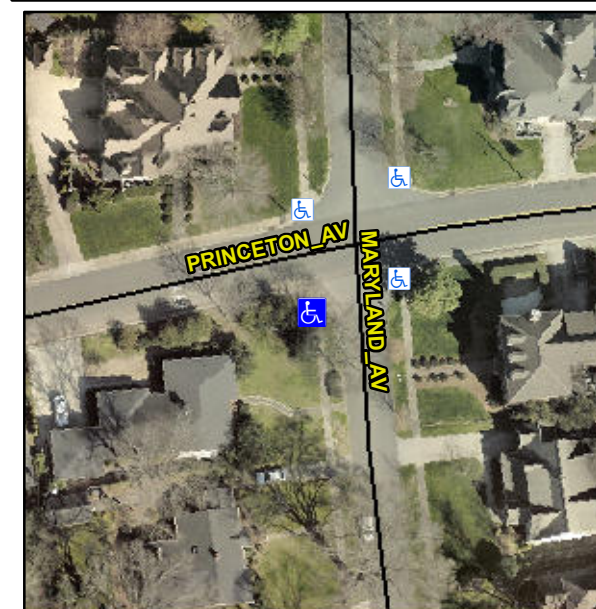
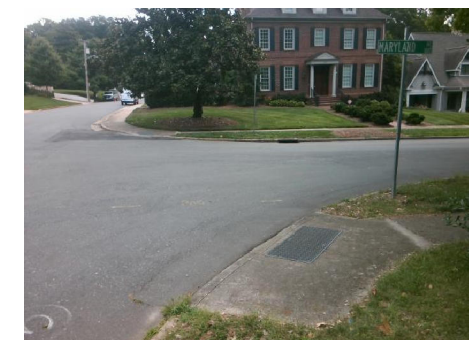
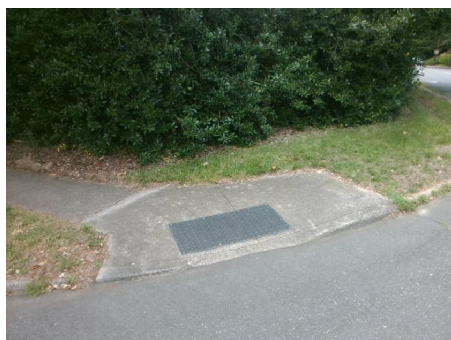
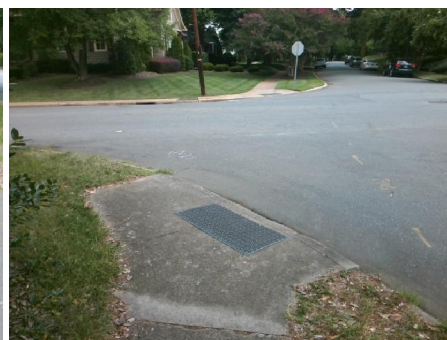
Not Found, R304.5.1, R304.5.3

Compliance	Description	Data	Compliance	Description	Data
N/A	Ramp Length (in)	63.0	Yes	Ramp Slope (%)	5.6
No	Ramp Width (in)	44.0	No	Ramp XSlope (%)	8.6
N/A	Flare Type LT	N/A	N/A	Flare Type RT	N/A
N/A	Flare Slope LT (%)	N/A	N/A	Flare Slope RT (%)	N/A
N/A	Flare Traversable LT?	N/A	N/A	Flare Traversable RT?	N/A
N/A	Landing Length (in)	N/A	N/A	DWS Provided?	N/A
N/A	Landing Width (in)	N/A	N/A	DWS Contrast?	N/A
N/A	Landing Slope (%)	N/A	N/A	DWS Length (in)	N/A
N/A	Landing X Slope (%)	N/A	N/A	DWS Full Width?	N/A
N/A	Landing Curb? (Y/N)	N/A	N/A	DWS Offset (in)	N/A
N/A	Shared Landing?	N/A			
N/A	Gutter Ponding?	N/A	N/A	Gutter Slope (%)	N/A
N/A	Gutter Lip Ht (in)	N/A	N/A	Gutter X Slope (%)	N/A
N/A	Painted X Walk1?	No	N/A	Painted X Walk2?	No
	X Walk 1 Direction	To E		X Walk 2 Direction	To N
N/A	X Walk 1 Width (in)	N/A	N/A	X Walk 2 Width (in)	N/A
	X Walk 1 Slope (%)	4.9		X Walk 2 Slope (%)	8.9
	X Walk 1 X Slope (%)	5.1		X Walk 2 X Slope (%)	2.1

N/A	Ramp inside XWalk1?	N/A	N/A	Ramp inside XWalk2?	N/A
	Road Slope (%)	3.0	N/A	Clear Space?	N/A
	Road X Slope (%)	6.1	N/A	Clear Space to XWalk (in)	N/A
N/A	Any Obstructions?	N/A	N/A	Storm Grate/Utility Hazard?	N/A
	Obstruction Type			Storm Grate/Utility Type	
		N/A			N/A
			Yes	Surface Condition? (G/P)	Good

Remove & Replace Curb Ramp With Two New Directional Ramps or Equivalent.
