# Access Compliance Report

## Public Rights-of-Way

### (Curb Ramps)

Intersection ID: 10020687	Main Street: BEAM_RD	Cross Street: N/A	Location: NE
ADA ID: D7E3DA23F434	Ramp Type: BlendTrans1	Initial Pass/Fail: Pass	Overall Compliance: No
		Severity Score: 7.75

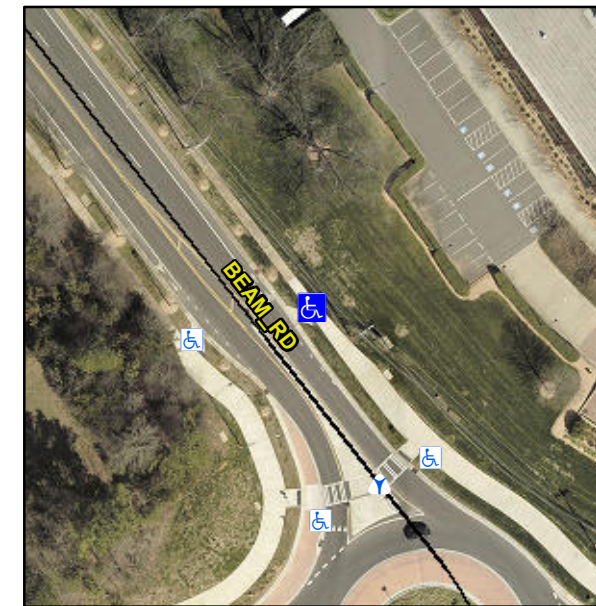
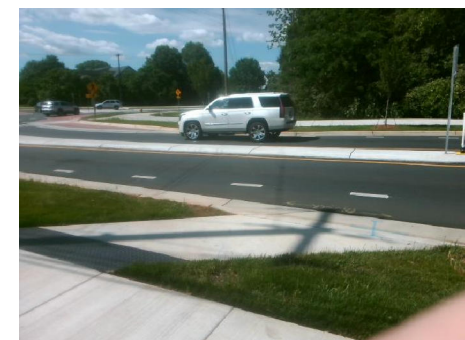
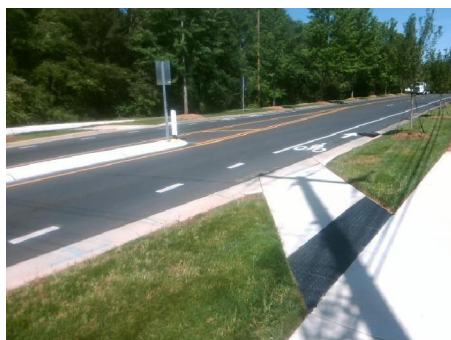
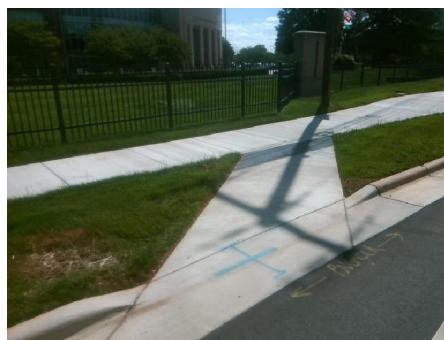
**Not Found, R304.5.3, R305.2, R302.7.2**

Compliance	Description	Data	Compliance	Description	Data
N/A	Ramp Length (in)	96.0	Yes	BlendTrans Slope (%)	3.9
Yes	Ramp Width (in)	68.0	No	BlendTrans XSlope (%)	2.3
N/A	Flare Type LT	None	N/A	Flare Type RT	None
N/A	Flare Slope LT (%)	N/A	N/A	Flare Slope RT (%)	N/A
N/A	Flare Traversable LT?	N/A	N/A	Flare Traversable RT?	N/A
Yes	Landing Length (in)	75.0	Yes	DWS Provided?	Yes
Yes	Landing Width (in)	108.0	Yes	DWS Contrast?	Yes
Yes	Landing Slope (%)	0.3	Yes	DWS Length (in)	24.0
Yes	Landing X Slope (%)	1.7	Yes	DWS Full Width?	Yes
N/A	Landing Curb? (Y/N)	No	No	DWS Offset (in)	70.0
N/A	Shared Landing?	No			
Yes	Gutter Ponding?	No	Yes	Gutter Slope (%)	4.1
No	Gutter Lip Ht (in)	0.5	Yes	Gutter X Slope (%)	1.4
N/A	Painted X Walk1?	No	N/A	Painted X Walk2?	N/A
	X Walk 1 Direction	To SW		X Walk 2 Direction	N/A
	X Walk 1 Width (in)	N/A		X Walk 2 Width (in)	N/A
	X Walk 1 Slope (%)	3.0		X Walk 2 Slope (%)	N/A
	X Walk 1 X Slope (%)	1.1		X Walk 2 X Slope (%)	N/A

N/A	Ramp inside XWalk1?	N/A	N/A	Ramp inside XWalk2?	N/A
	Road Slope (%)	1.1		Clear Space?	Yes
	Road X Slope (%)	3.0	N/A	Clear Space to XWalk (in)	N/A
Yes	Any Obstructions?	No	Yes	Storm Grate/Utility Hazard?	No
	Obstruction Type			Storm Grate/Utility Type	
		N/A			N/A
			Yes	Surface Condition? (G/P)	Good
			No	Curb Slope (%)	10.0

**Remove & Replace Curb Ramp With Two New Directional Ramps or Equivalent.**
